DURABILITY OF ALUMINIZED TYPE 2 COATED CORRUGATED STEEL PIPE EXPOSED THROUGHOUT THE UNITED STATES

August 2014

J. PETER AULT, P.E

ELZLY TECHNOLOGY CORPORATION

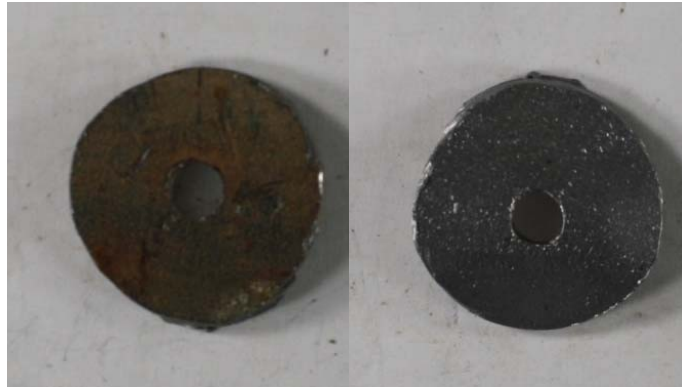
Fairplay, CO “as-received” Fairplay, CO “post-blasting”
Figure 1. Representative Sample Cleaning

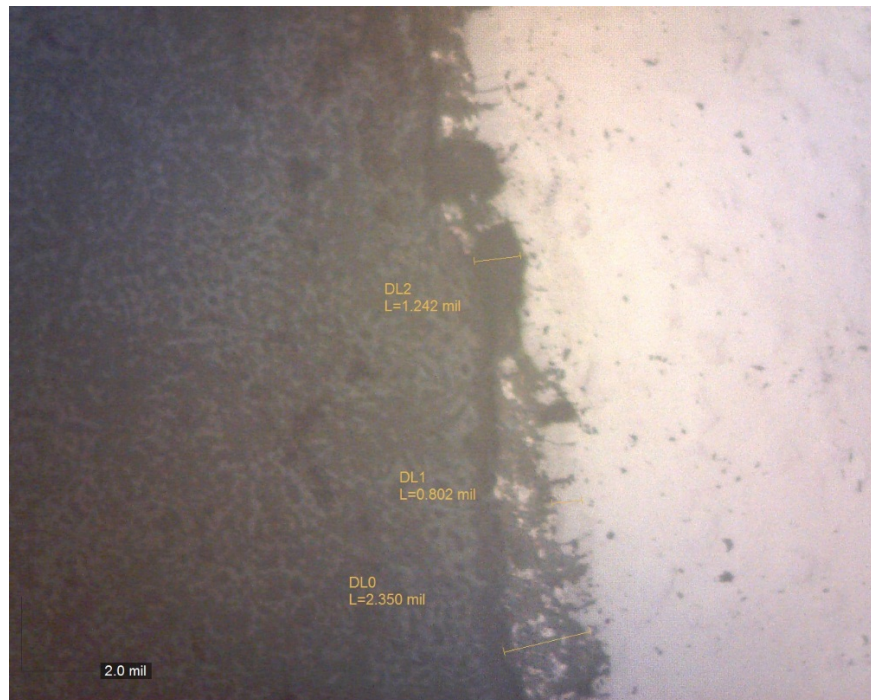
Precision cuts were made through an area of interest on each sample. This was often through the most severe pitting found on the sample, but this single pit may not be representative of the pitting severity along the whole sample or the whole pipe. These pieces were mounted in epoxy and finished with a progressively finer abrasive. Finally, a Nital etchant was used to expose the aluminum-iron alloy formed during the pipe sheet production process. Once sample preparation was complete the samples were able to be observed under a microscope. Digital images were analyzed to determine the thickness of the Aluminized coating, alloy layer (when aluminum was removed) and depth of any pits observable within the sample. Figure 2 shows representative measurements.

Figure 2. Representative Micrograph

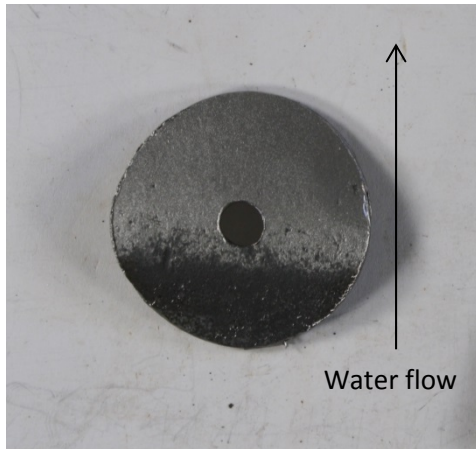
One additional important parameter in the study of CSP is the bedload experienced. The effect of bedload on Aluminized pipe is obvious from the wear patterns in the aluminum oxide layer. As would be expected, bedload only wears the Aluminized coating from the upstream side of the corrugation. Figure 9 and Figure 10 show examples with wear on one side of the corrugation. The lower portion of the sample is a darker color, because bare steel is exposed due to abrasion. Analysis of the pits on each sample reveals two unique characteristics of pitting. In samples where abrasion is a clear concern we see a large density of pits on the upstream half of the sample (see Figure 9). These pits typically have a wide mouth in comparison to their depth, and are also deeper than most general corrosion pits. Pitting

which is associated with general corrosion typically has a low pit density, is scattered throughout the entire surface area of the sample and has shallower depth than pits in areas subject to abrasion. Typically, these pits are also much narrower than those found in abrasion areas. If abrasion levels beyond those recommended are present, a decrease in service life is to be expected.

Figure 9. Coating removed due to bed load

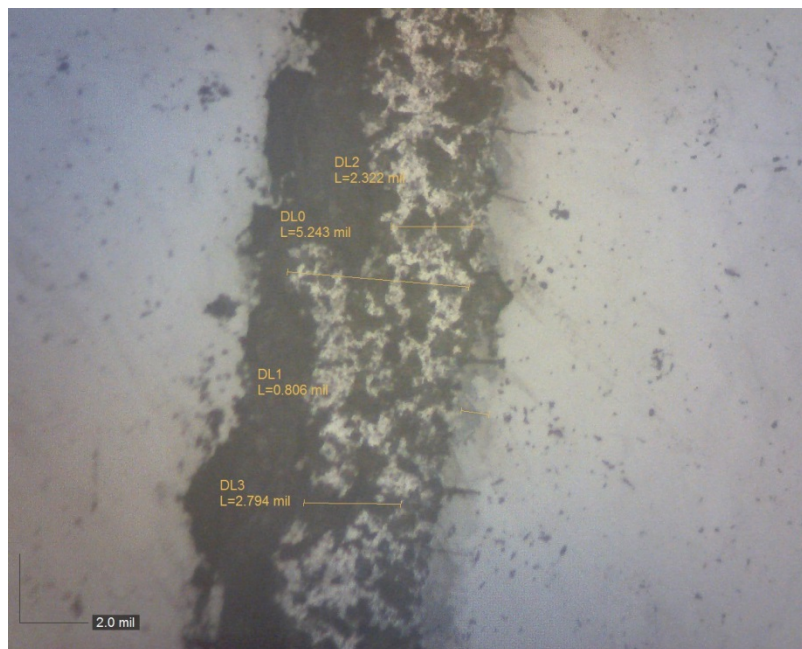
Figure 11 illustrates how coating thickness can vary across a sample even with small cross sections. In this image a coating thickness of over 5 mils is measured in one location with only 2 mils of coating thickness a short distance from that.

Figure 11. Potential Variation in Coating Thickness

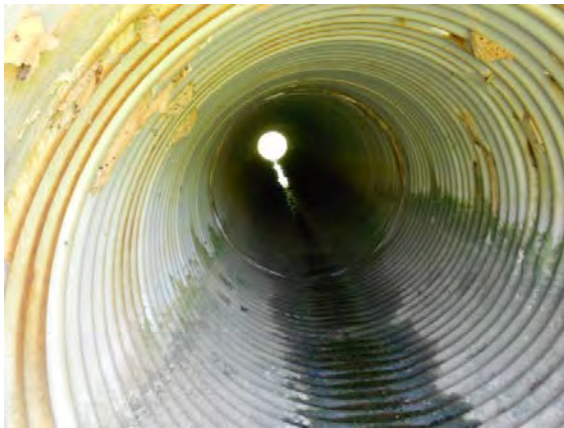
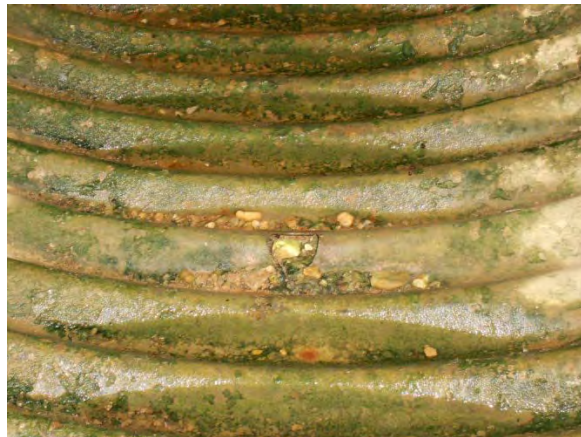
- Pipe is in good condition
- Installed in an abrasive environment

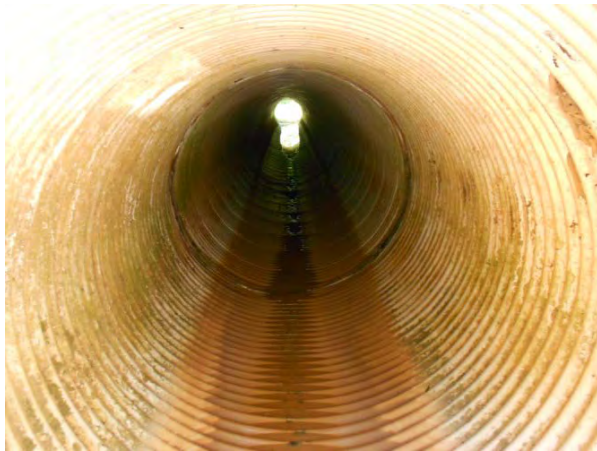
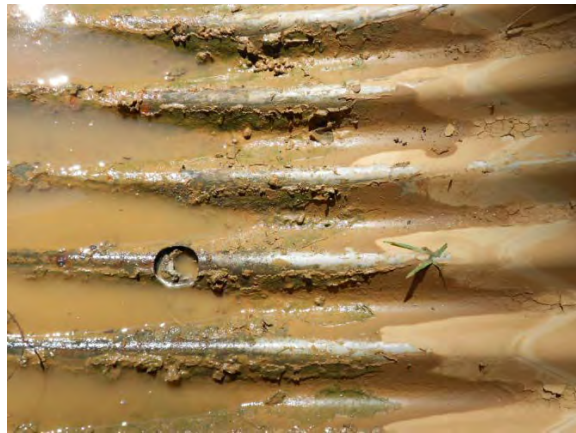
- Pipe is in good condition
- No pavement distress

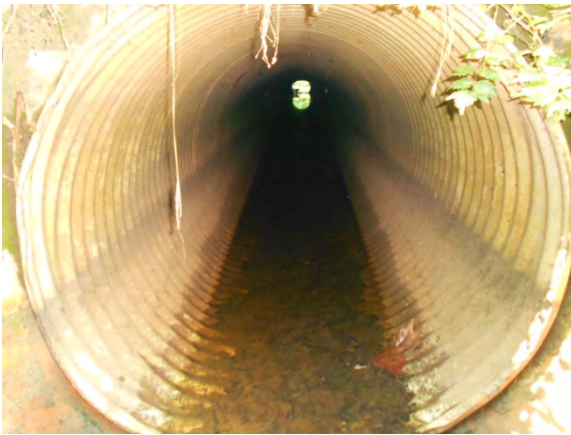
- Pipe and coating are in good condition
- No pavement distress

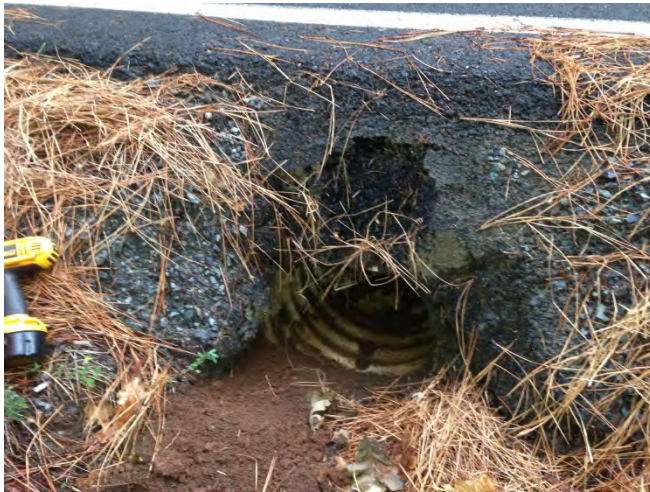
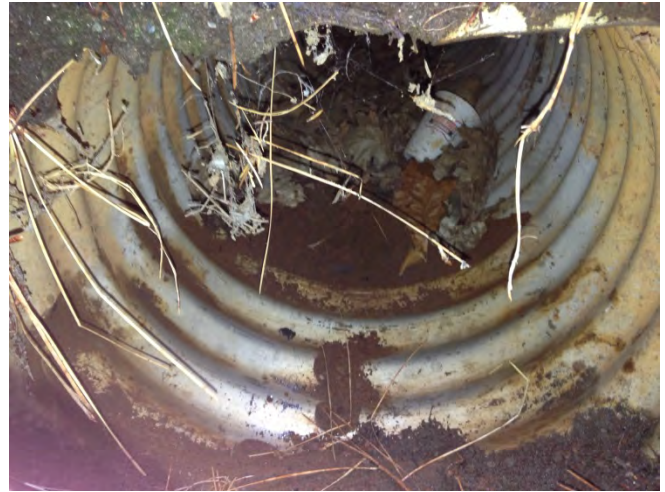
- Aluminized Type 2 coating in good condition
- No pavement distress
- Previous trepan holes were not corroded further

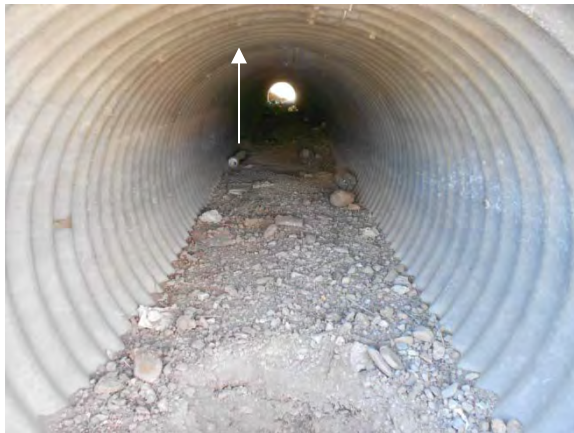
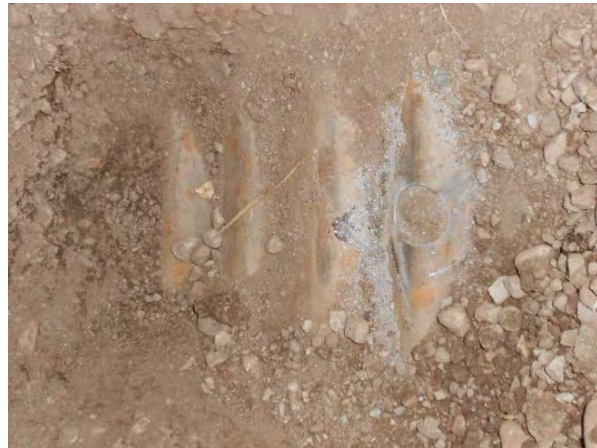
- There was no pavement distress
- No further corrosion of trepan holes
- Pipe is in good condition

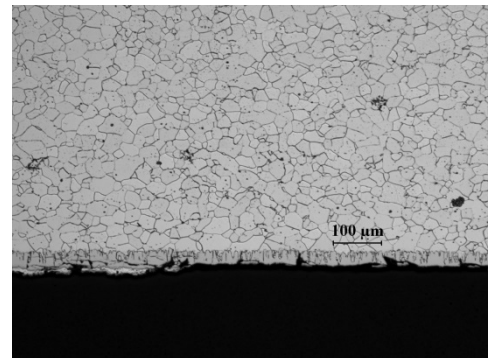
- Surface area coated: 20%
- Minimum thickness: 0.00 mils
- Maximum thickness: 1.40 mils (35.5 μm)
- Maximum pit depth: 1.31 mils

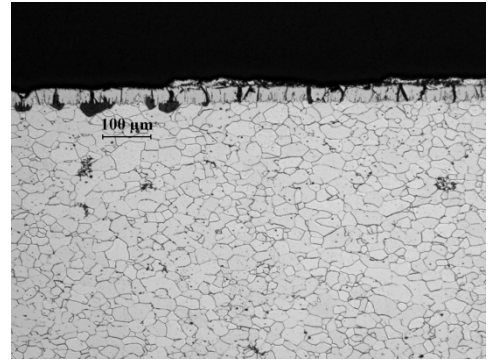
- Surface area coated: 40%
- Minimum thickness: 0.00 mils
- Maximum thickness: 0.89 mils (22.5 μm)
- Maximum pit depth: 2.57 mils

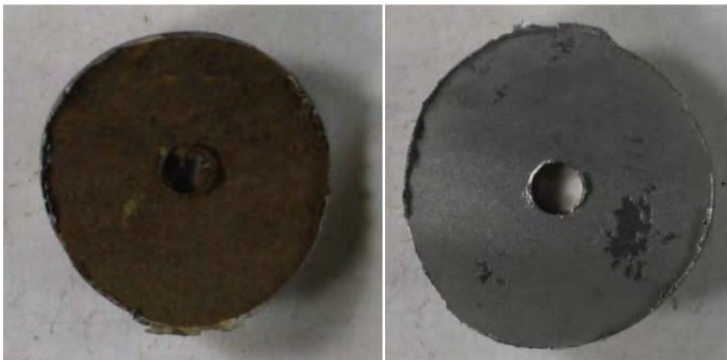
- Surface area coated: 95%
- Minimum thickness: 0.58 mils
- Maximum thickness: 1.38 mils (35 μm)
- Maximum pit depth: 0.84 mils

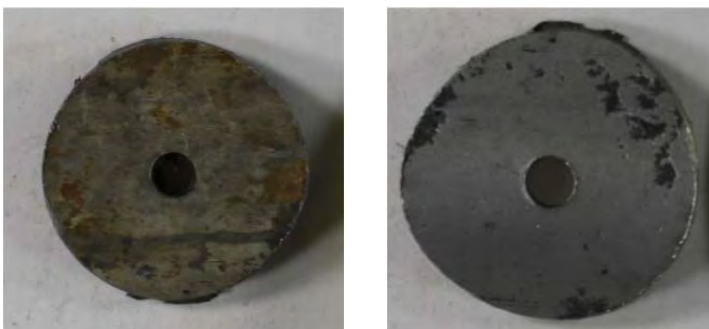
- Surface area coated: 90%
- Minimum thickness: 0.00 mils
- Maximum thickness: 1.78 mils (45 μm)
- Maximum pit depth: 1.23 mils

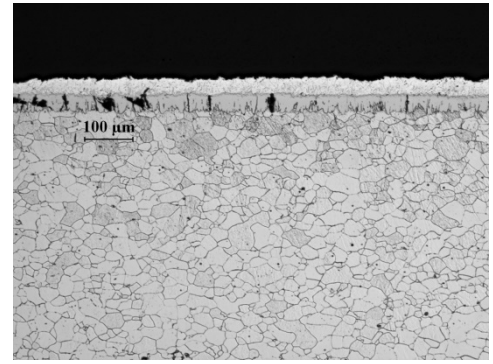
- Surface area coated: 85%
- Minimum thickness: 0.00 mils
- Maximum thickness: 1.71 mils (43 μm)
- Maximum pit depth: 8.00 mils

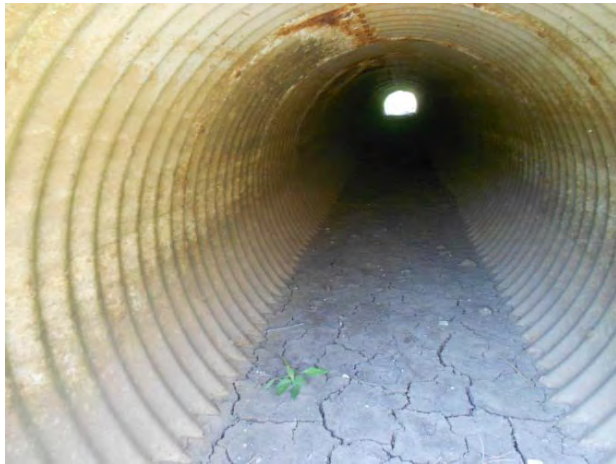
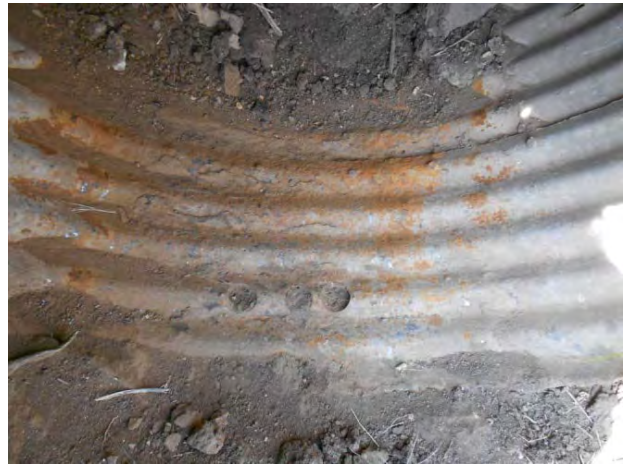
- Scaling at the invert could be cause for increase in thickness measurements
- Pipe is in good condition
- No further corrosion of previous trepan holes

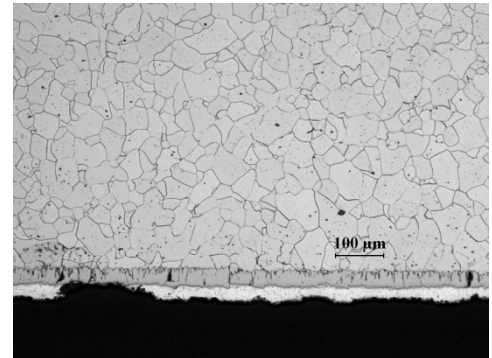
- Surface area coated: 5%
- Minimum thickness: 0.00 mils
- Maximum thickness: 0.00 mils
- Maximum pit depth: 0.73 mils

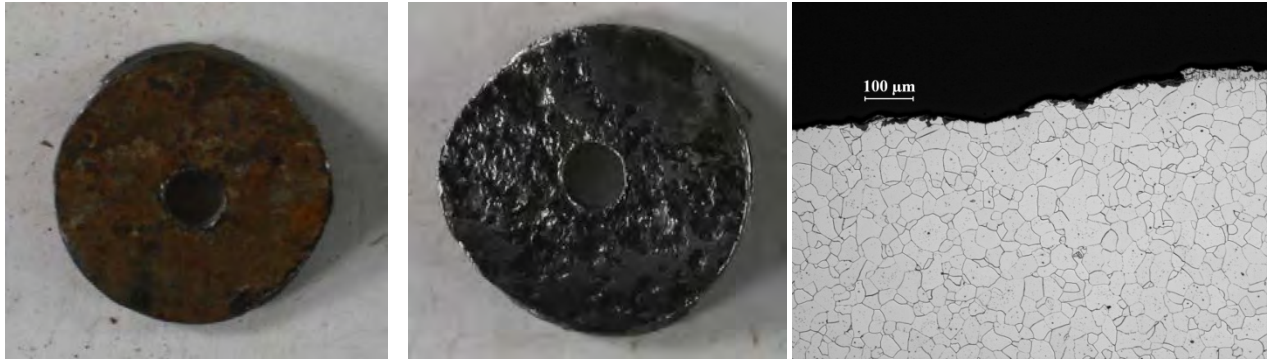
- Surface area coated: 0%
- Minimum thickness: 0.00 mils
- Maximum thickness: 0.00 mils
- Maximum pit depth: 37.00 mils

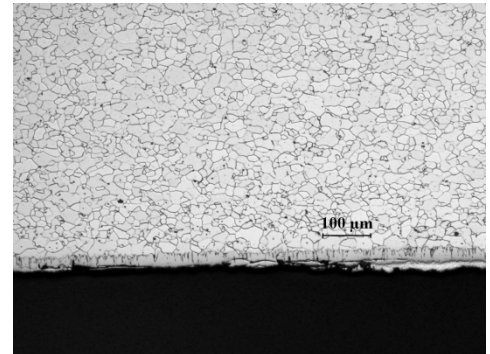
- Surface area coated: 5%
- Minimum thickness: 0.00 mils
- Maximum thickness: 0.00 mils
- Maximum pit depth: 14.00 mils

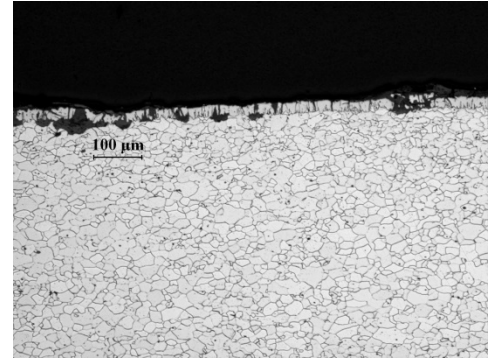
- Surface area coated: 5%
- Minimum thickness: 0.00 mils
- Maximum thickness: 0.00 mils
- Maximum pit depth: 12.00 mils

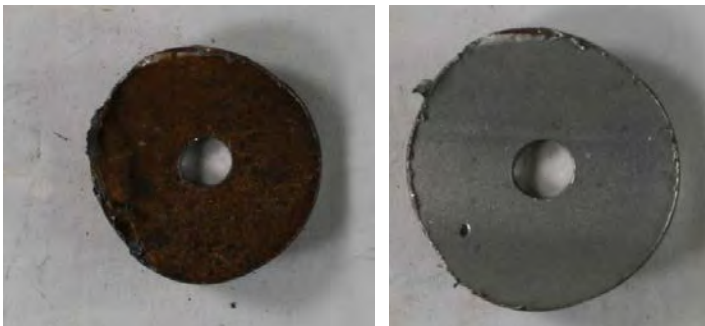
- Surface area coated: 100%
- Minimum thickness: 0.00
- Maximum thickness: 1.13 (29 μm)
- Maximum pit depth: 2.31 mils

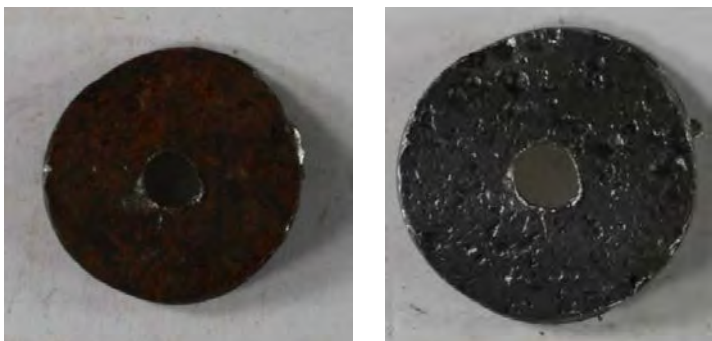
- Surface area coated: 0%
- Minimum thickness: 0.00
- Maximum thickness: 0.00
- Maximum pit depth: 41.00 mils

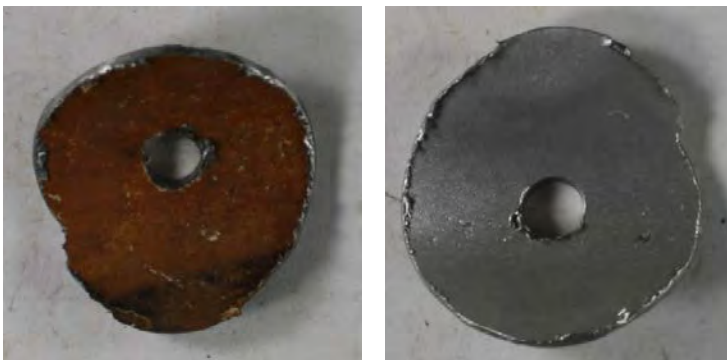
- Surface area coated: 100%
- Minimum thickness: 0.00 mils
- Maximum thickness: 1.65 mils (42 μm)
- Maximum pit depth: 0.00 mils

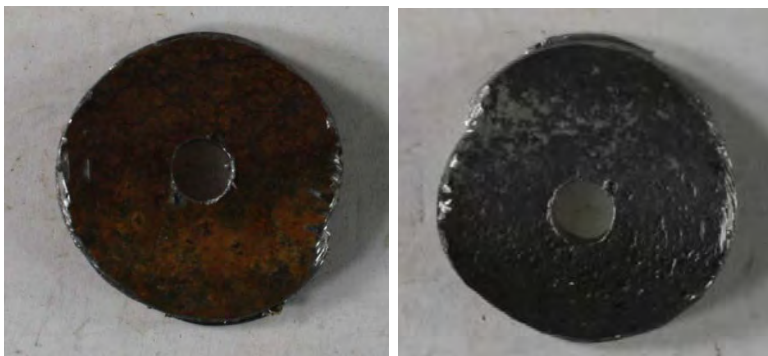
- Surface area coated: 10%
- Minimum thickness: 0.00 mils
- Maximum thickness: 0.00 mils
- Maximum pit depth: 10.50 mils

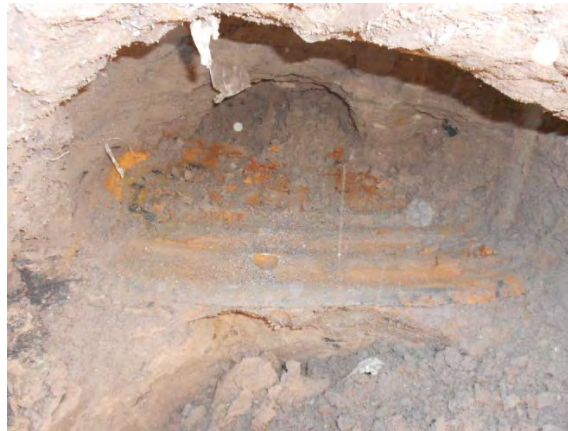
- Pipe appeared to be in fair condition
- Pipe is too full of silt to perform

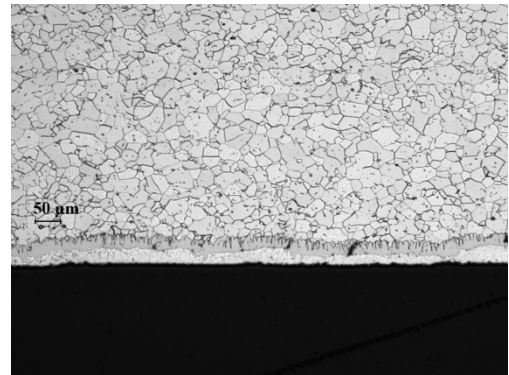
- Surface area coated: 100%
- Minimum thickness: 0.00 mils
- Maximum thickness: 1.87 mils (47.5 μ m)
- Maximum pit depth: 1.60 mils

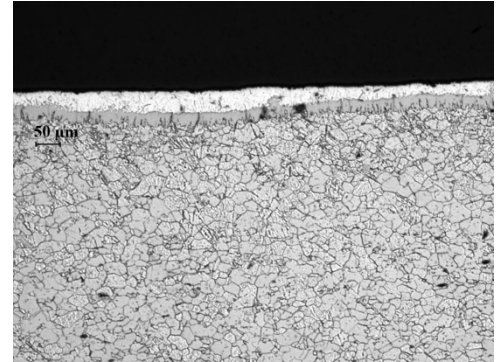
- Surface area coated: 90%
 - Minimum thickness: 0.00 mils
 - Maximum thickness: 2.19 mils (55.5 μ m)
 - Maximum pit depth: 11.00 mils
- *Note: largest visible pit is a result of the removal process

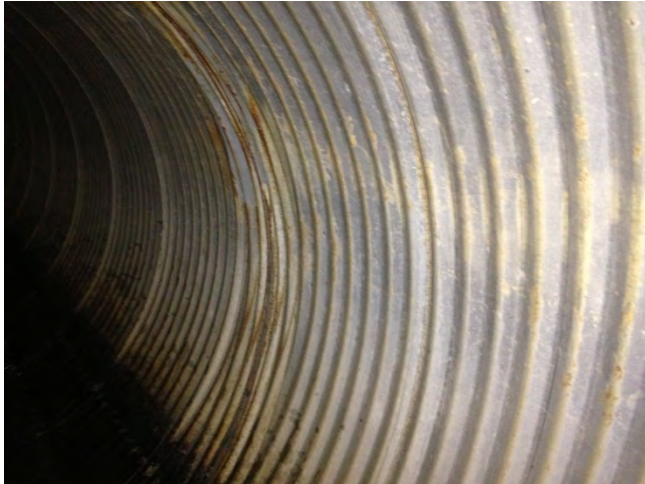
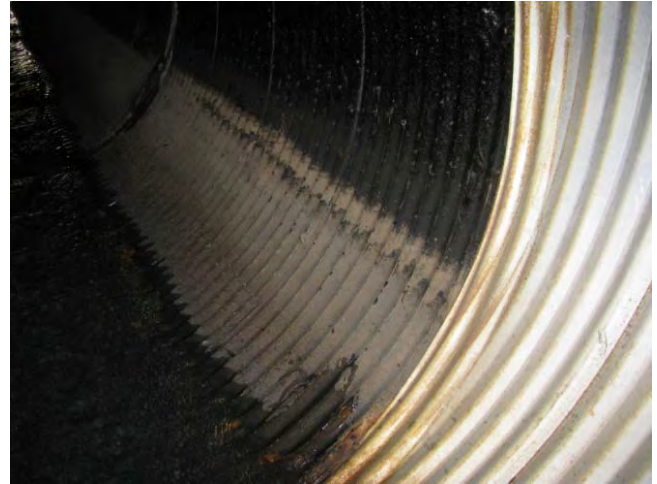
- Pipe is comprised of approximately 160 ft of ALT2 and 60 ft of asphalt coated galvanized at the upstream end
- Some cracking in the haunch areas of 3 sections appears to be from clay backfill that was used
- Maximum pit depth taken from section where another pilot hole had be started for the trepan evaluation

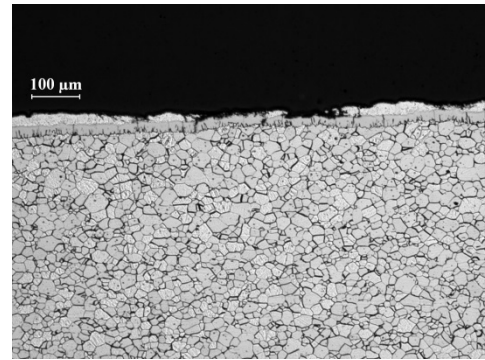
- Surface area coated: 55%
- Minimum thickness: 0.00 mils
- Maximum thickness: 1.05 mils (26.5 μm)
- Maximum pit depth: 2.28 mils

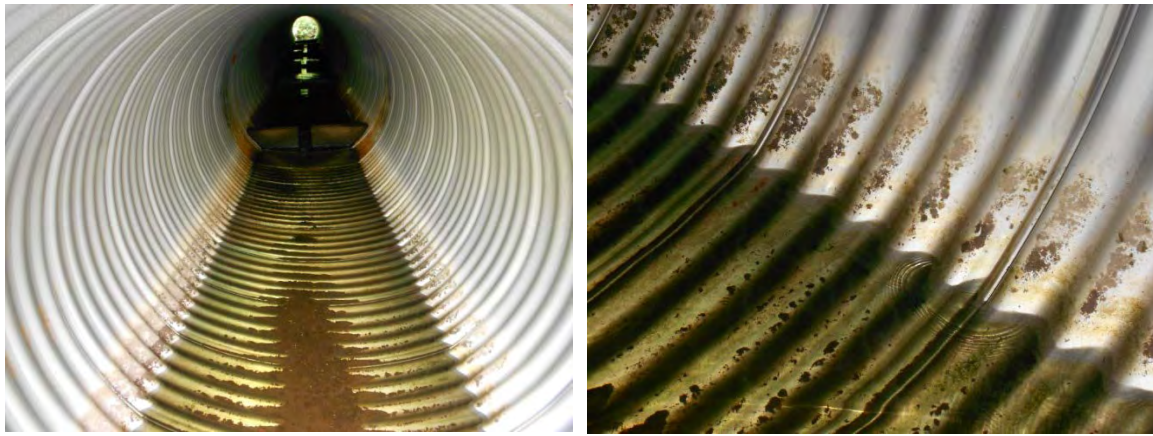
- Pipe and coating in good condition
- Pipe has baffles installed in the invert

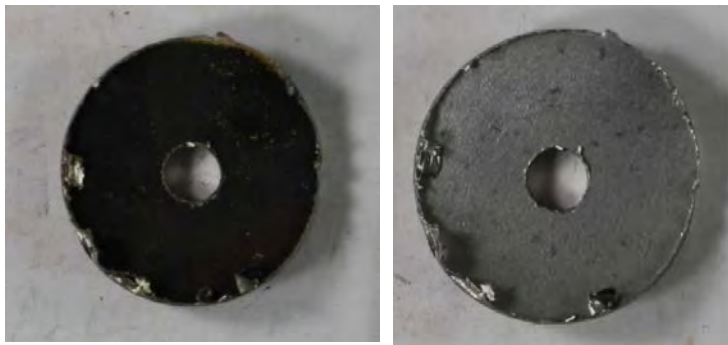
- Surface area coated: 100%
- Minimum thickness: 0.00
- Maximum thickness: 3.02 (76.5 μm)
- Maximum pit depth: 0.78 mils

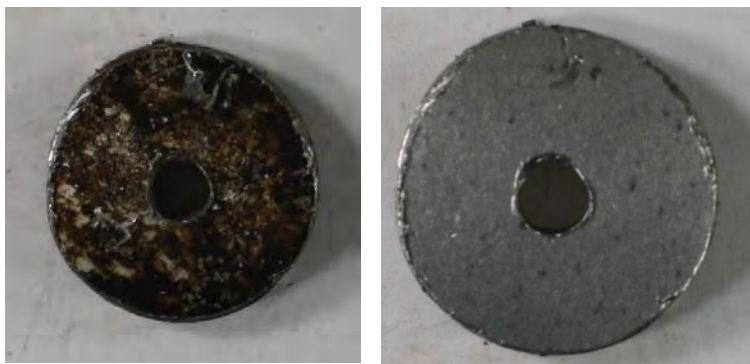
- Surface area coated: 100%
- Minimum thickness: 0.83
- Maximum thickness: 2.54 (64.5 μm)
- Maximum pit depth: 1.55 mils
