National
Corrugated Steel Pipe
Association

Condition Survey of Corrugated Steel Pipe Detention Systems

An Interim Report
March, 1999

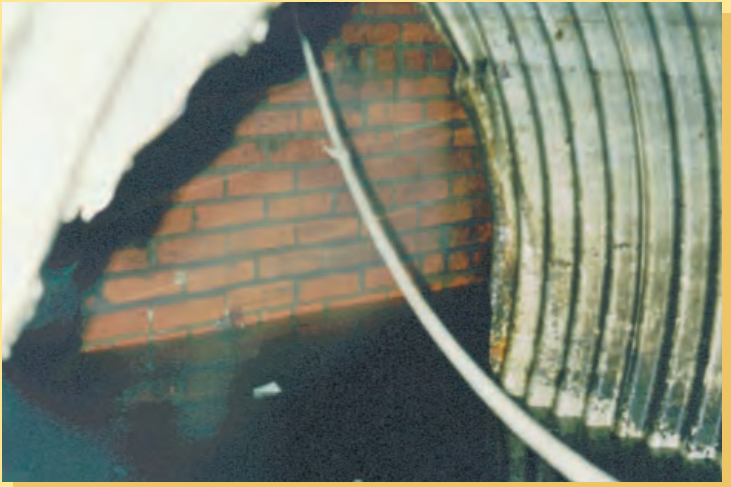
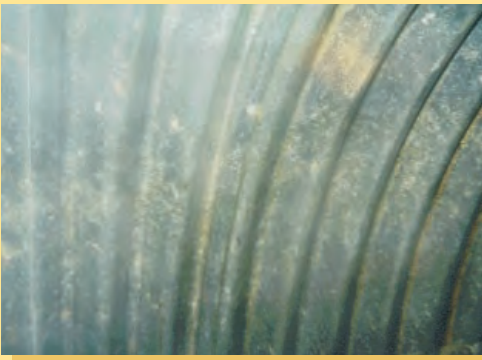
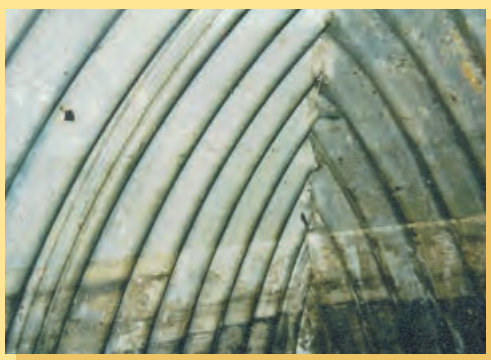
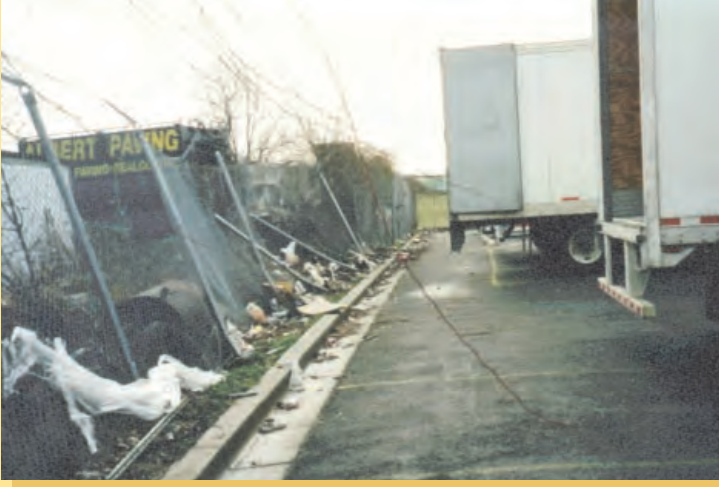
<p>Condition Rating</p> <p>Top95/100</p> <p>Sides95/100</p> <p>Invert.....75/90*</p> <p>Avg. Rating.....92.5</p>	<p>Age: 25 years</p> <p>Coating Type: Galvanized</p> <p>Diameter: 60"</p> <p>Corrugation: 1x3" Helical</p> <p>Land Use: Industrial</p> <p>Location: Montgomery County, Maryland</p>	<p>Comments:</p> <p>*18" standing water;</p> <p>could not see invert;</p> <p>rating based on probing.</p> <hr/> <hr/> <hr/>
--	---	--

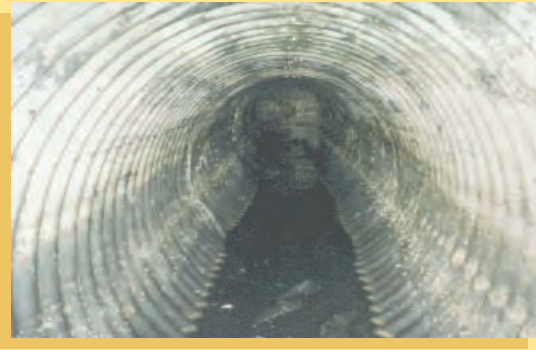
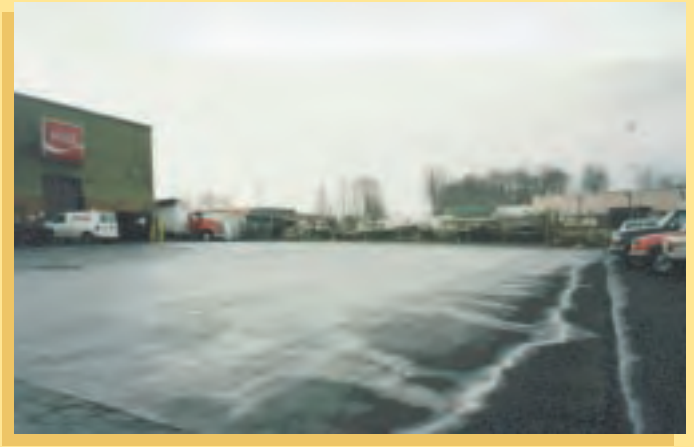
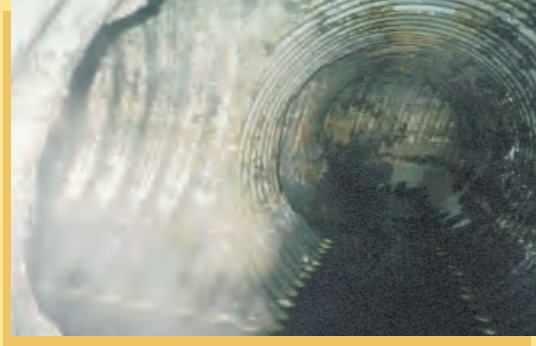
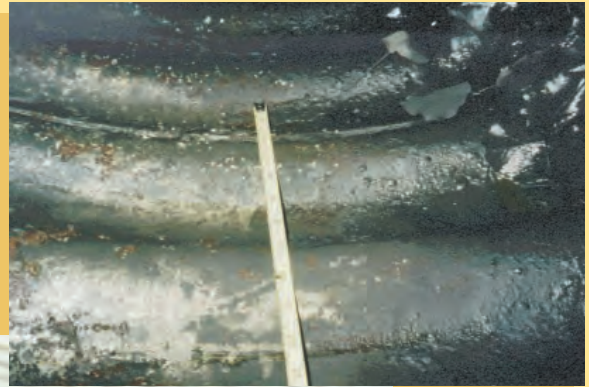
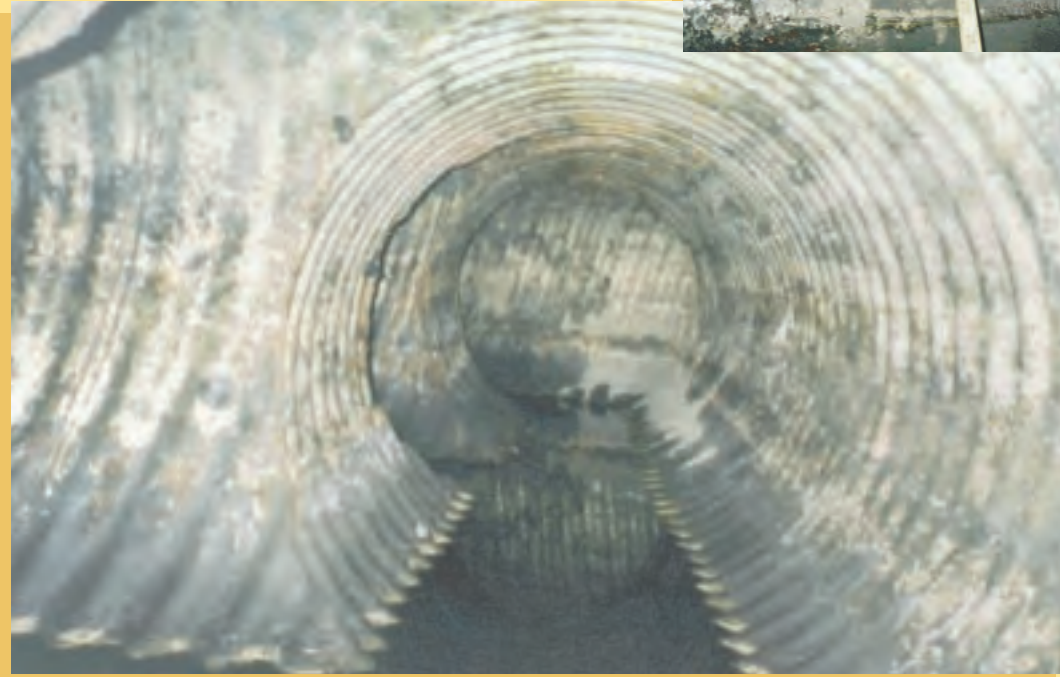
. SITE . 2 .

Top90/95
 Sides90/95
 Invert.....70*
Avg. Rating85

*Isolated pitting invert.

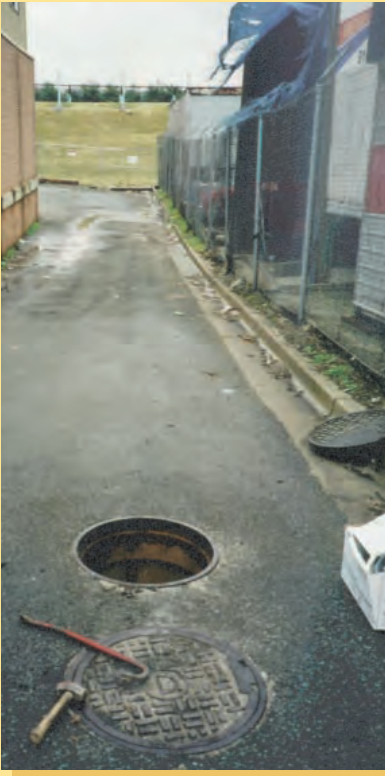
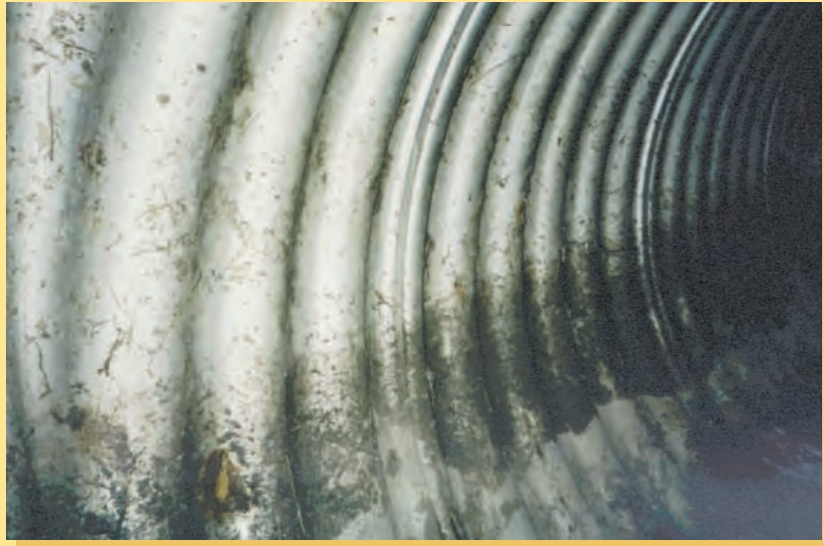
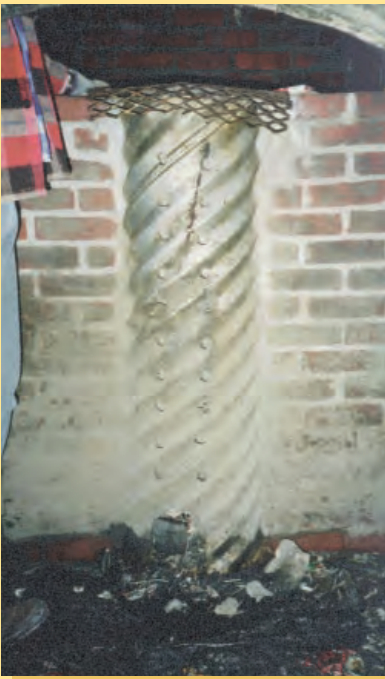
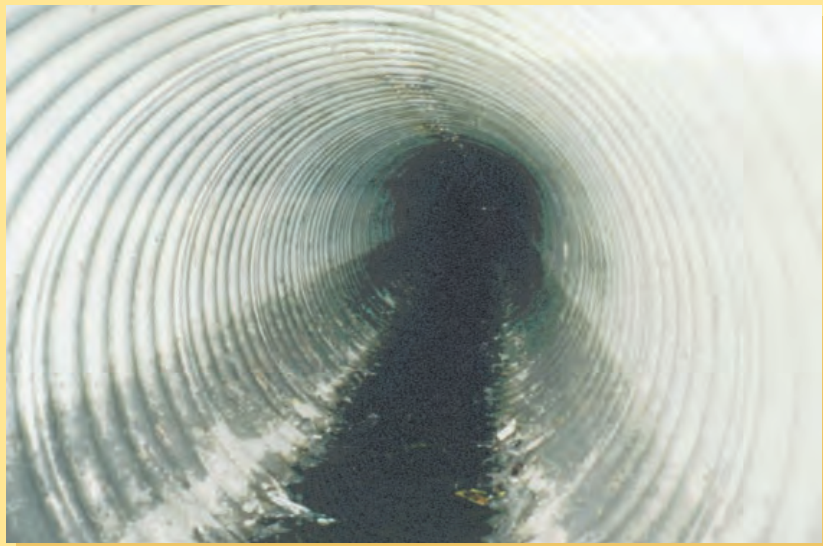
Top90/95
 Sides90/95
 Invert75
Avg. Rating.....86.7

Comments:
 36" saw-cuts in every
 corrugation to promote
 infiltration;
 stone backfill.

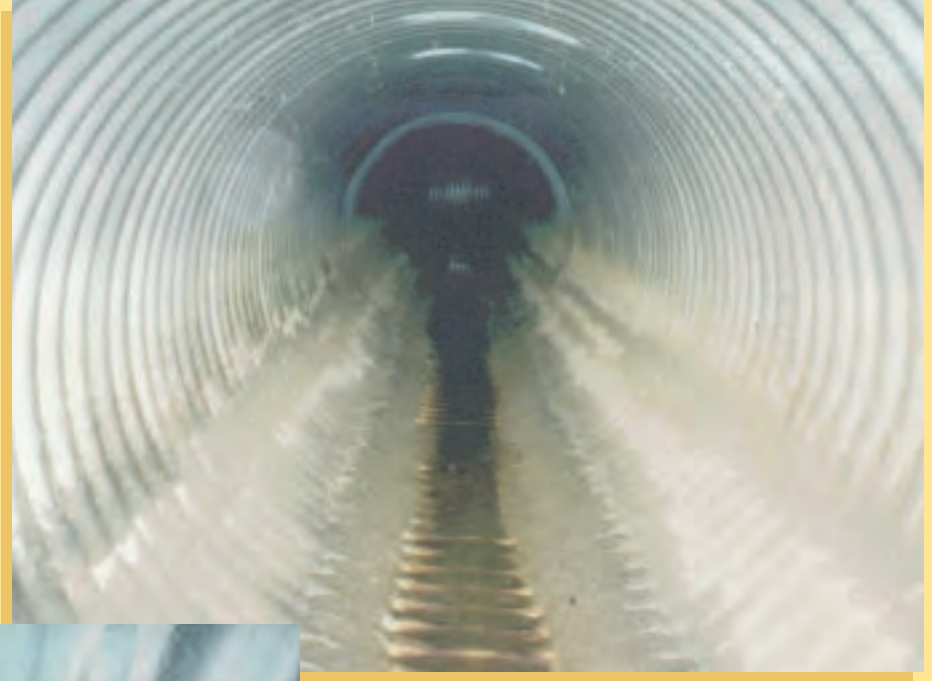
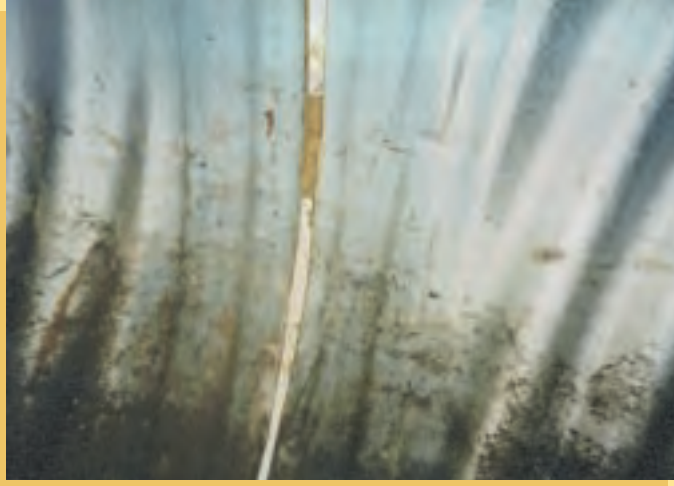
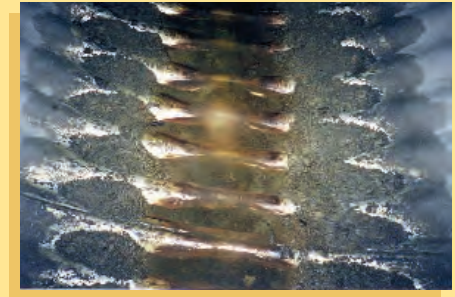
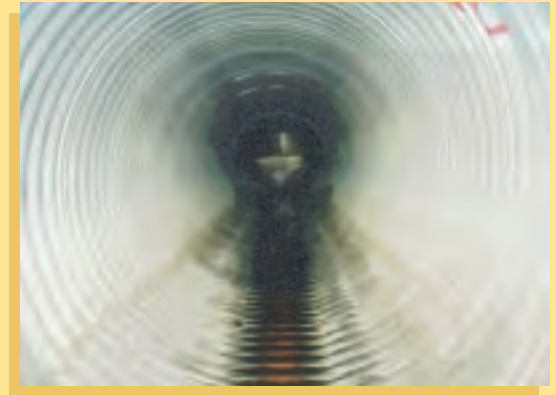
Top100
 Sides100
 Invert90
Avg. Rating.....96.7

Oil grit separator at
entrance.

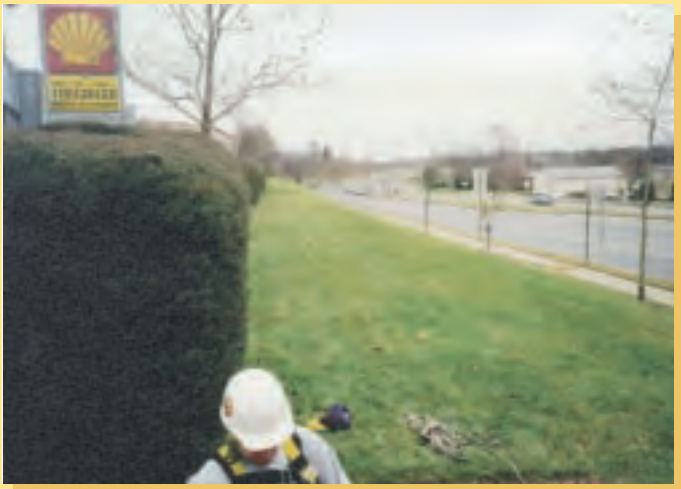
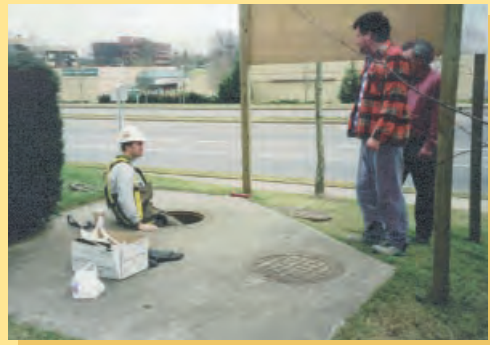
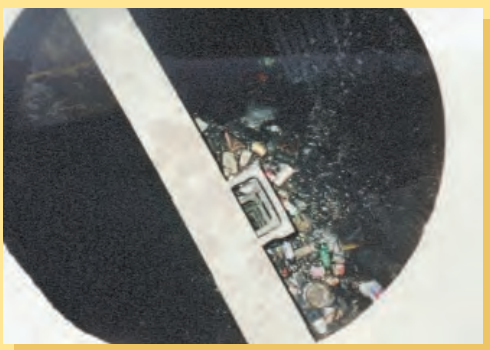
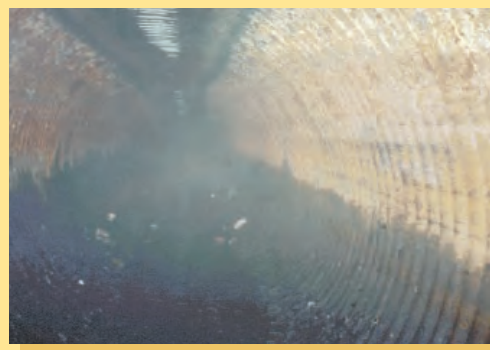
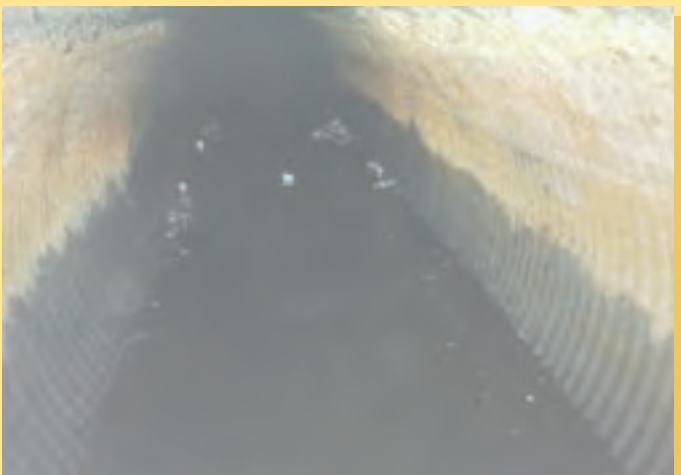
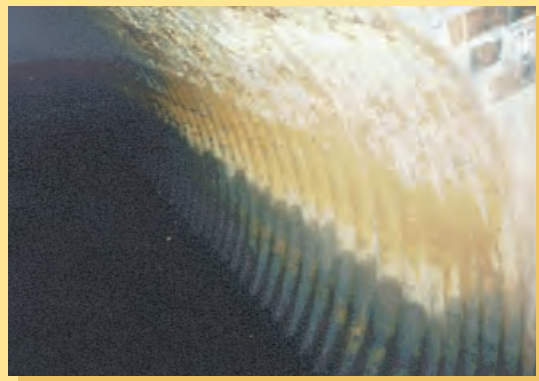
Top	90
Sides	70
Invert	60
Avg. Rating.....	73.3

Comments:
 6" low orifice clogged;
 24" standing water.
 Red rust on sides with
 coating loss.

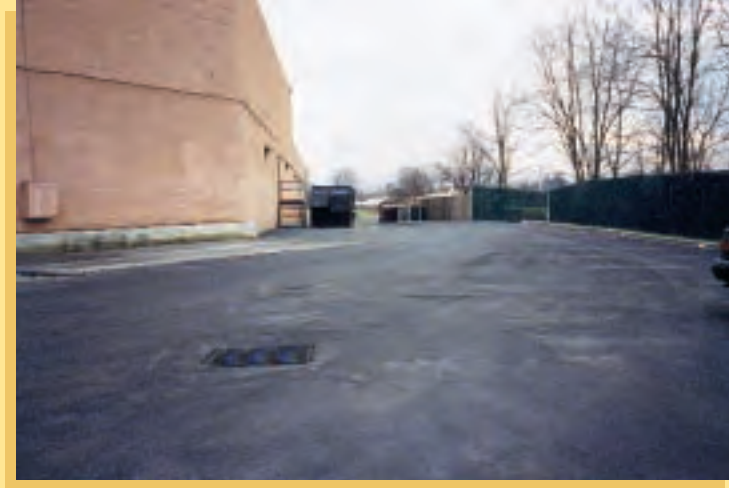
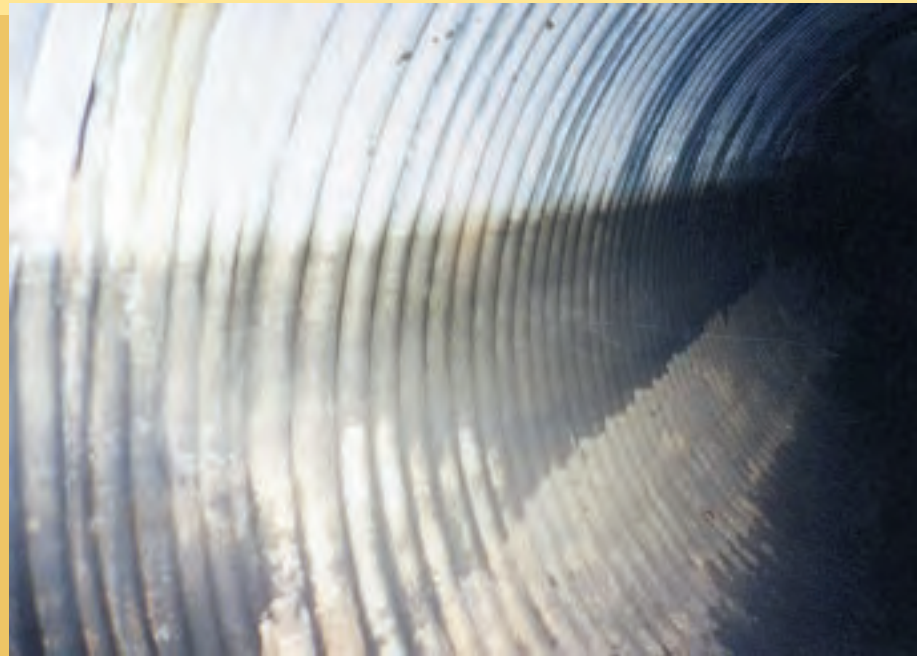
Top100
Sides90/95
Invert80/85
Avg. Rating.....91.7

Limited staining in
invert.

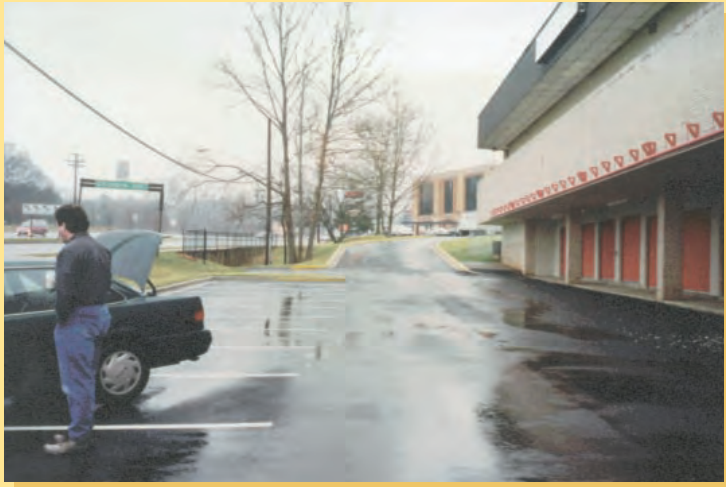
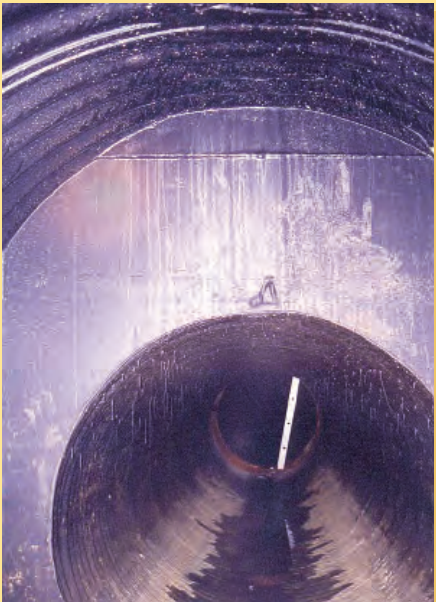
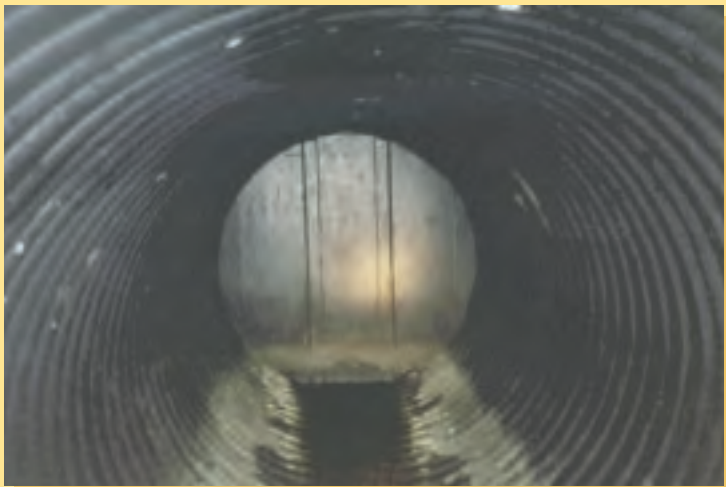
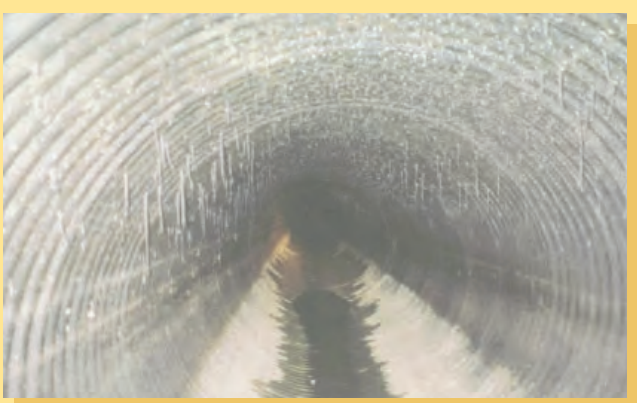
Top	100
Sides	100
Invert	100
Avg. Rating	100

Comments:
Bituminous coating
intact; no rust on exposed
galvanized surface.

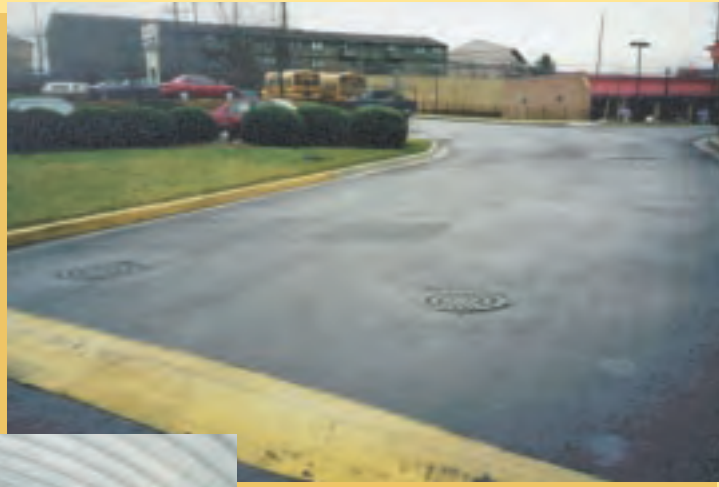
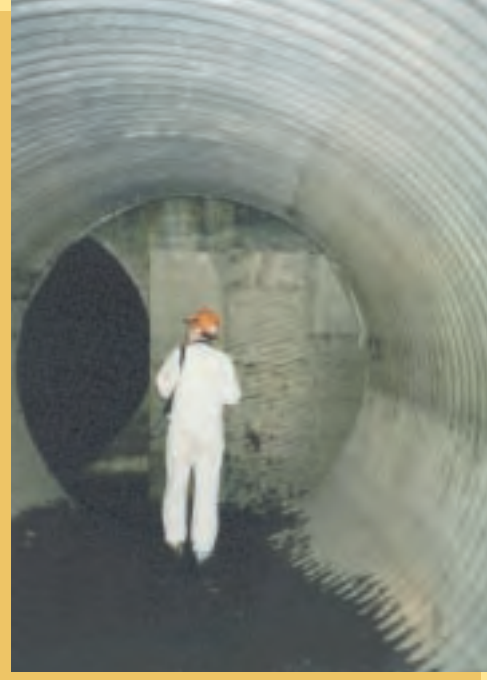
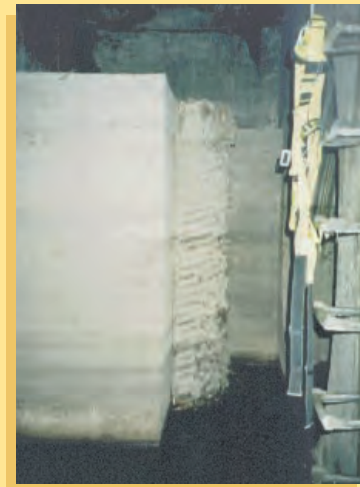
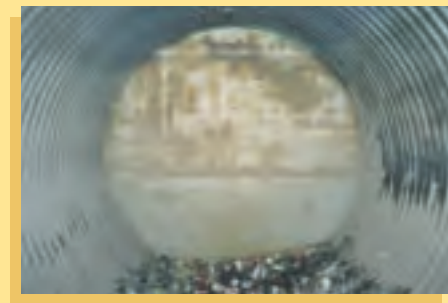
Top	95
Sides	95
Invert	85
Avg. Rating.....	91.2

Oil grit separator at
entrance;
minor soil trough joints;
no sign of gaskets with
joints.

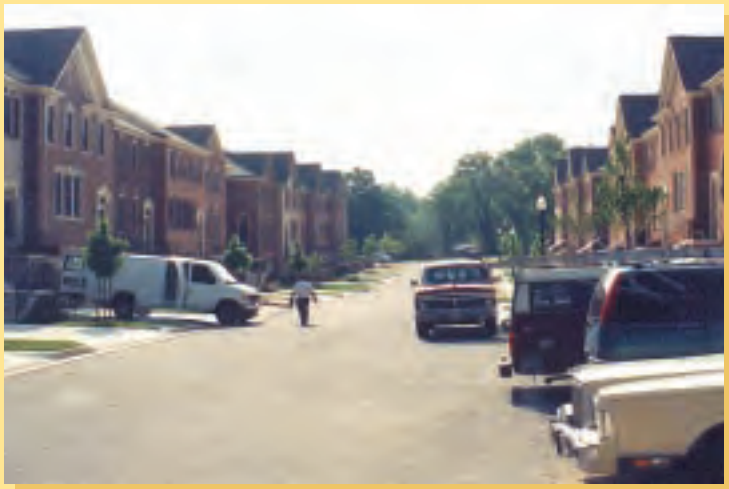
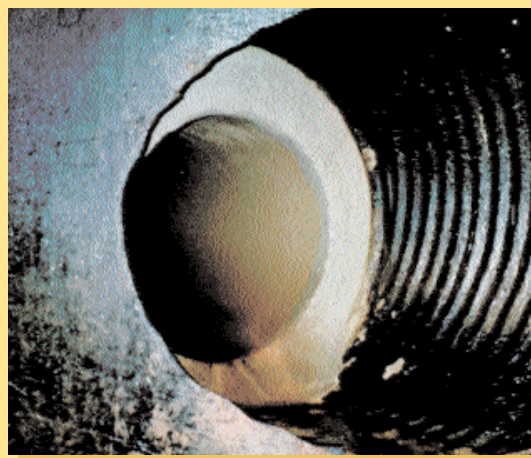
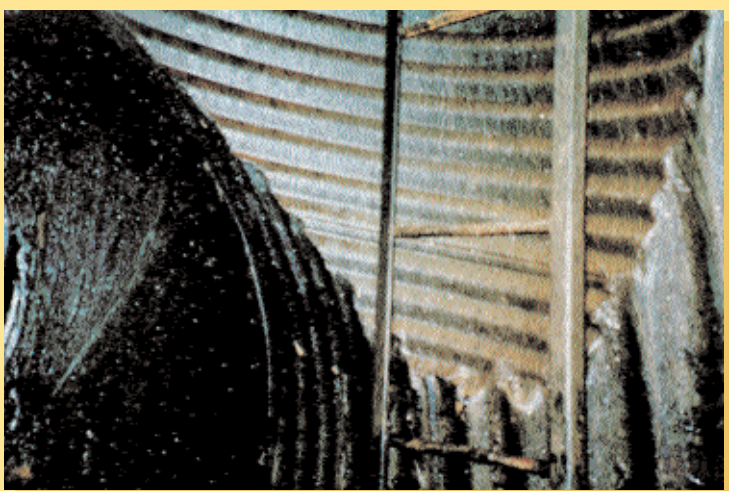
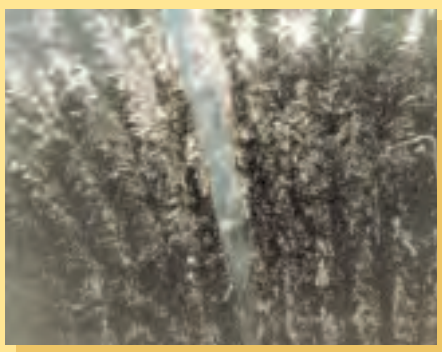
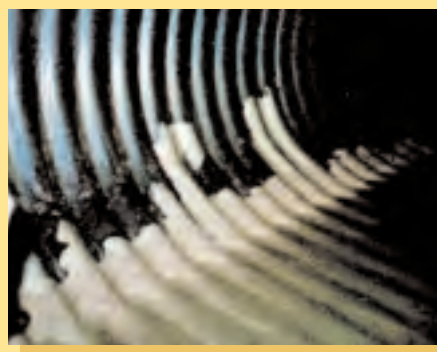
Top100
 Sides100
 Invert95/100
Avg. Rating.....99.2

Comments:
Asphalt coating removed
in sections of invert.
No signs of rust on
exposed galvanizing.

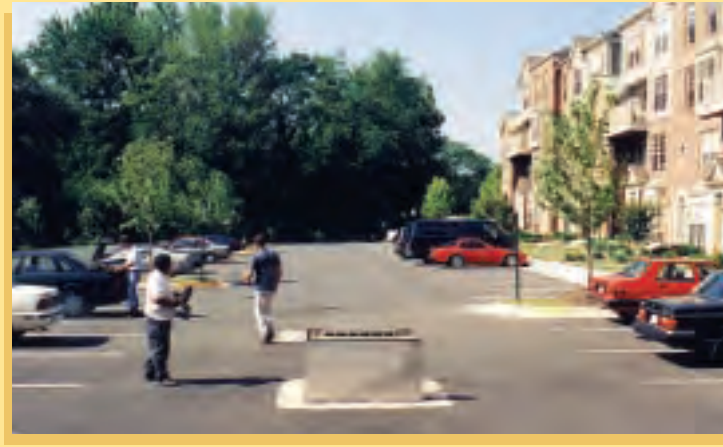
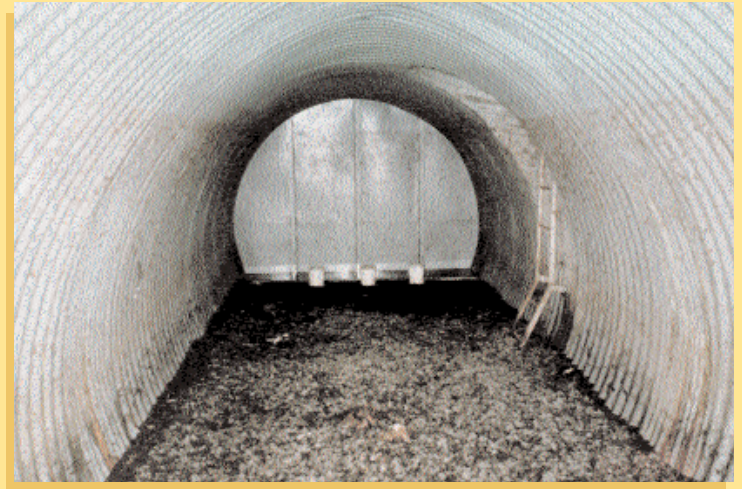
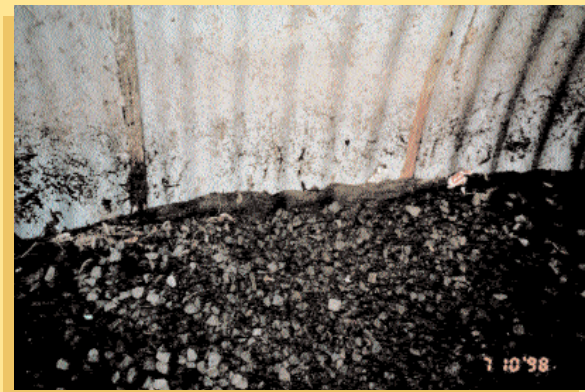
Top	100
Sides	100
Invert	N/A
Avg. Rating	100

Well drained;
 no signs of sediment
 clogging.

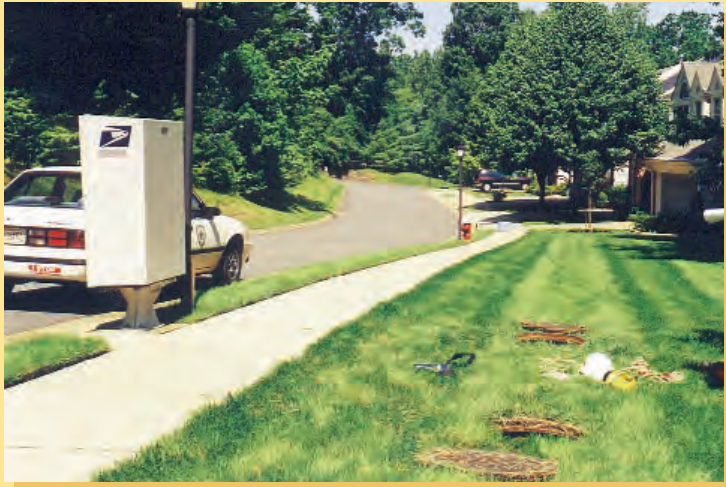
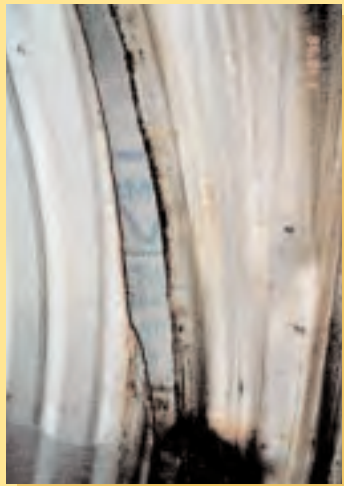
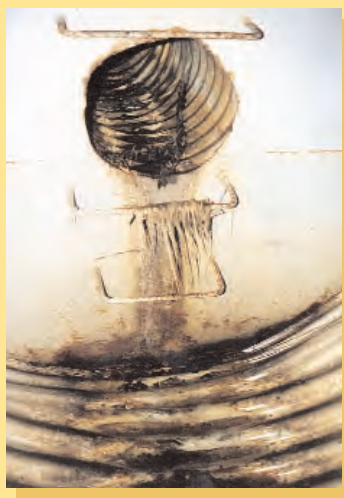
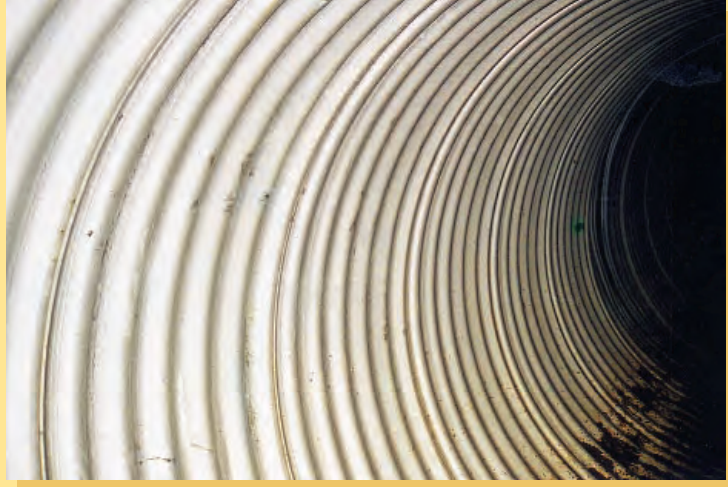
Top	100
Sides	100
Invert	95/100
Avg. Rating.....	99.2

Comments:
Light staining in invert.

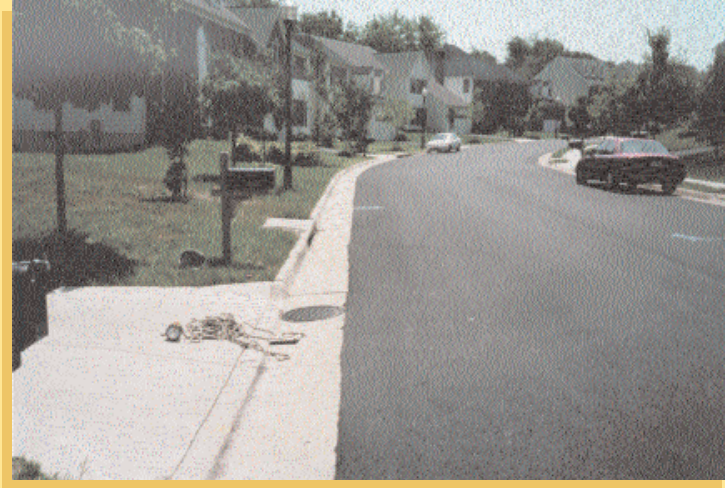
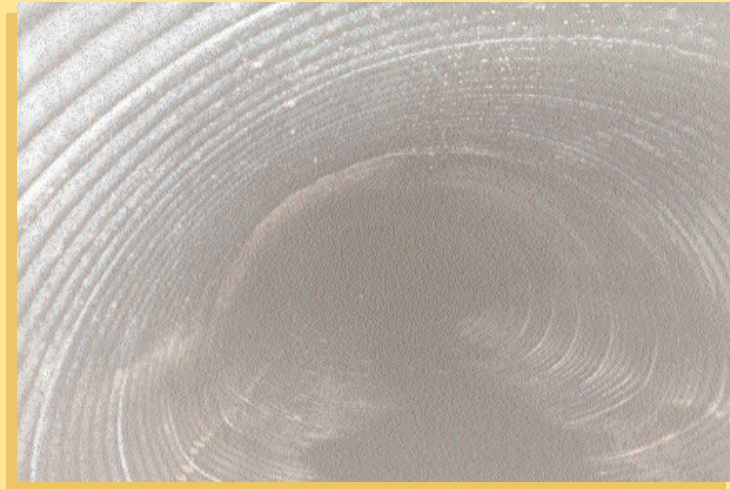
Top	100
Sides	100
Invert	95/100
Avg. Rating.....	99.2

Asphalt removed in
some areas; no rust on
exposed galvanized
surface.

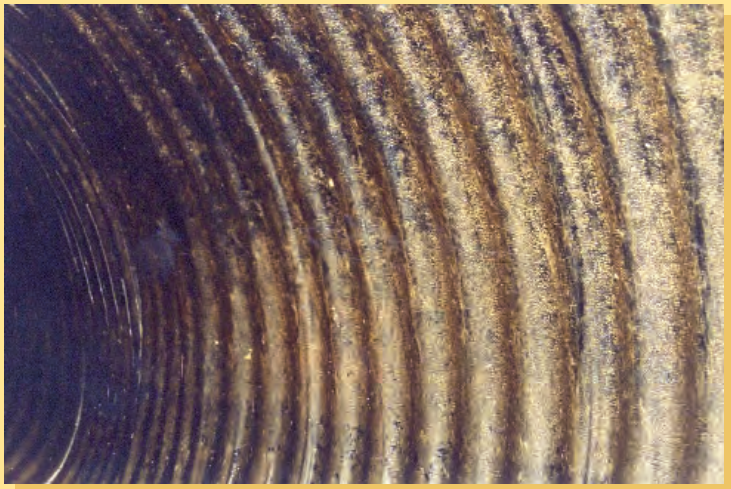
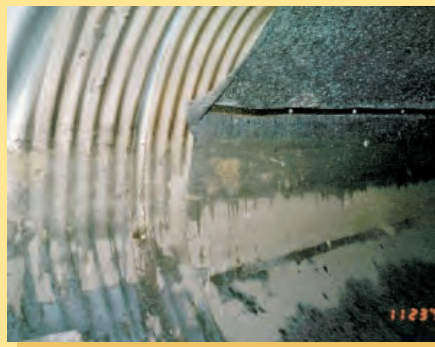
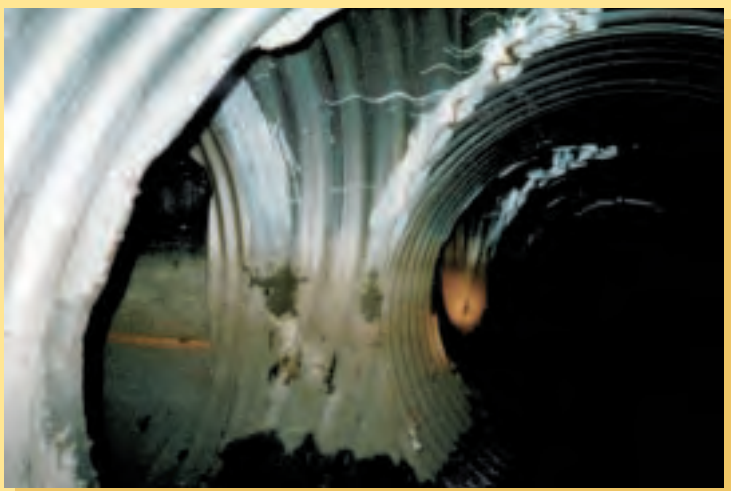
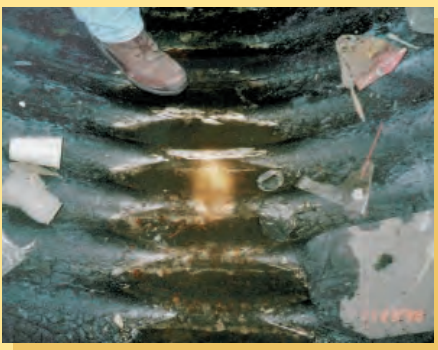
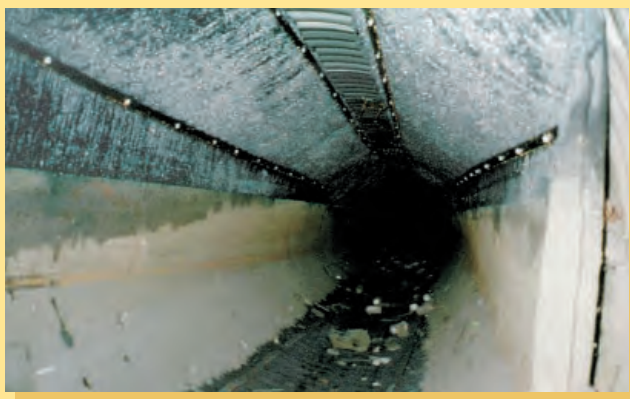
Top95/100
 Sides95/100
 Invert95
Avg. Rating.....96.7

Comments:
Oil grit separator at
entrance.
Non-woven geotextile
inside pipe to minimize
clogging of backfill stone.

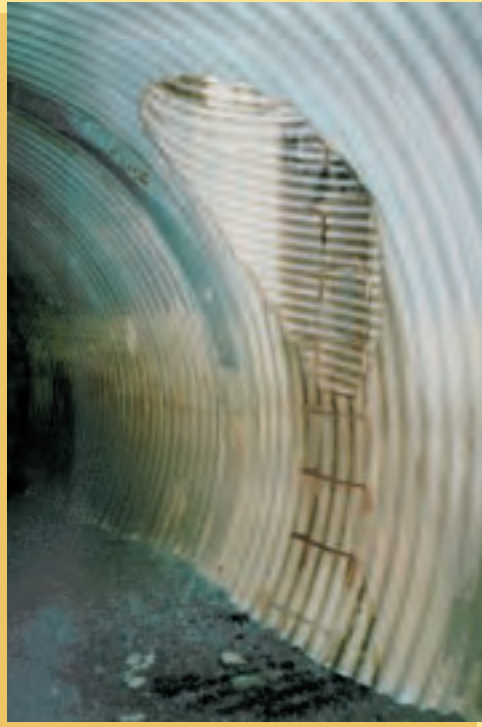
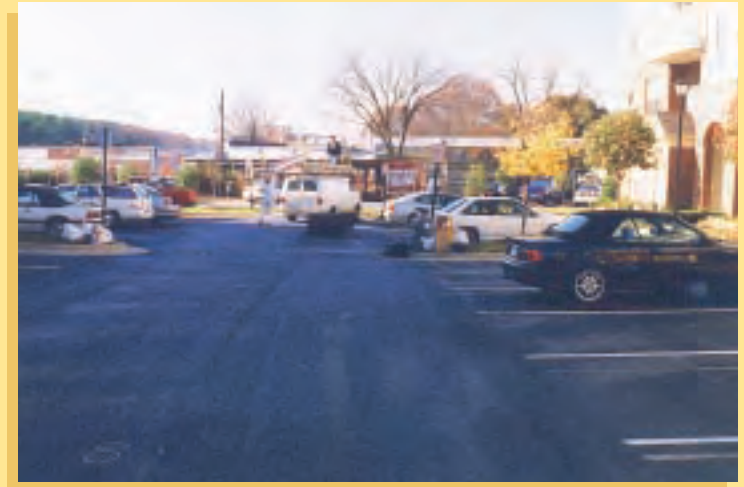
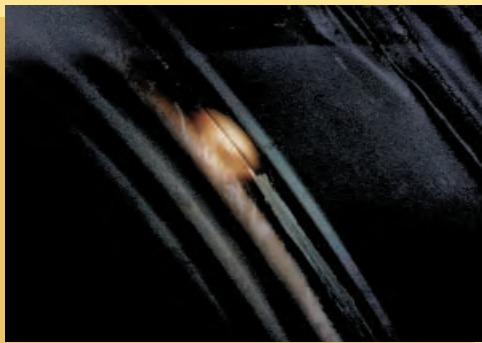
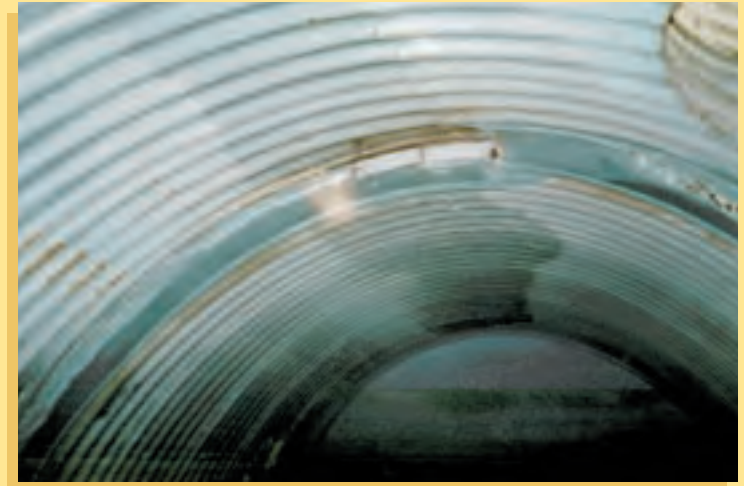
Top95/100
 Sides95/100
 InvertN/A
Avg. Rating.....97.5

Little to no debris;
no signs of clogging;
return valve open.
