# SERVICE LIFE EVALUATION OF CORRUGATED STEEL PIPE

Storm Water Detention  
Systems in the Metropolitan  
Washington, DC Area

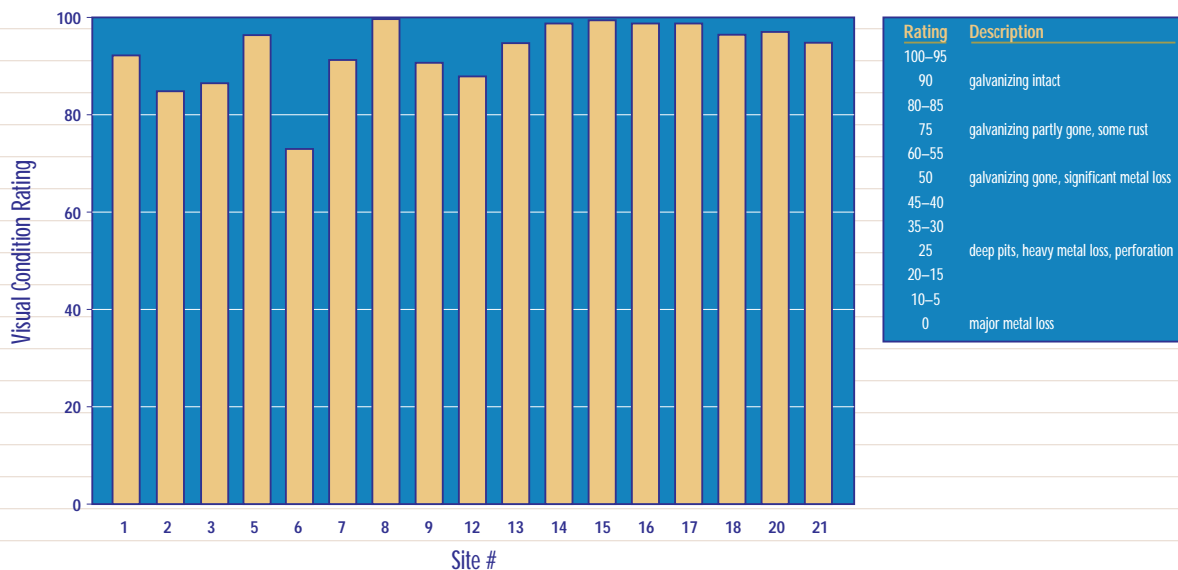
Figure 1. Average Coating Rating

average condition rating (crown, sides, invert) based on a visual rating scale developed by Corpro, 1991.<sup>2</sup> Most systems still had the zinc layer intact after about 25 years of service. There were no signs of visible deflection and most joints appeared to be soil tight.

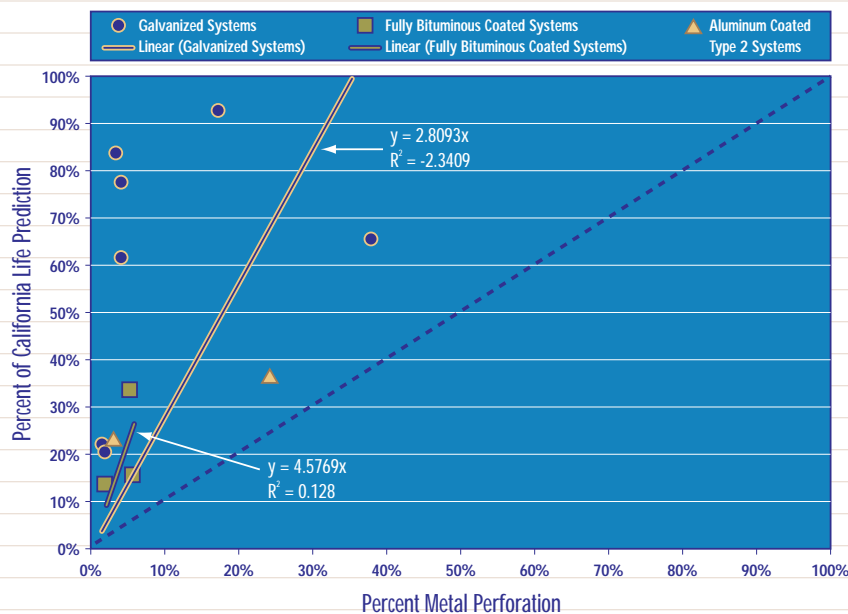
Figure 2. Percent Metal Perforation vs. California Prediction

crown of the pipe where the galvanizing was metallographically determined to be in-tact at nominally the original thickness. System 6 was the only system where an original thickness was difficult to determine, but a sufficiently conservative estimate was made based on measurements of the coupons. Figure 2 shows the data plotted in a manner similar to that used by Potter. Best-fit lines were regressed through all of the data for galvanized and asphalt coated pipes. No plot was made for aluminum coated pipes due to a lack of sufficient number of data points.

Using all data points, the analysis suggests that the galvanized systems are performing 2.8 times as well as the California Method would predict while the fully bituminous coated systems are performing 4.6 times as well as the California Method would predict for galvanized material. It should be noted that this multiplier increases to 7.3 times for galvanized systems if Site #6 is ignored. The inspection of the systems support the conclusion that the galvanized detention systems will last more than twice as long as the California Method might predict.
