DURABILITY OF ALUMINIZED TYPE 2 COATED CORRUGATED STEEL PIPE EXPOSED THROUGHOUT THE UNITED STATES

August 2014

J. PETER AULT, P.E

ELZLY TECHNOLOGY CORPORATION

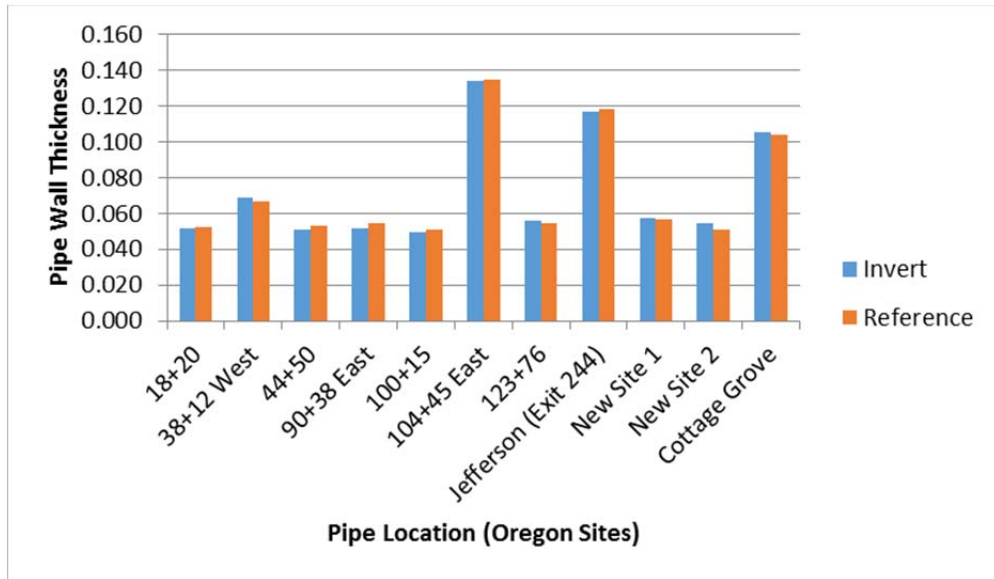
Figure 12. Comparison of Pipe wall thickness measurements.

field if they can be accessed. Because of variability in sheet thickness, it is recommended that reference thickness measurements be made at the top of the pipe where coating loss is unlikely and compared to the invert where thickness loss is typically the worst. Figure 12 presents UT measurements made in Oregon during this study.

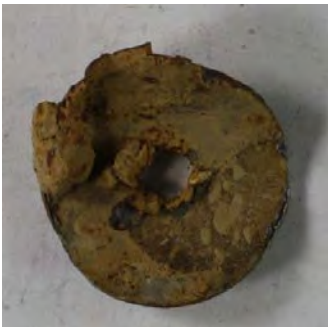
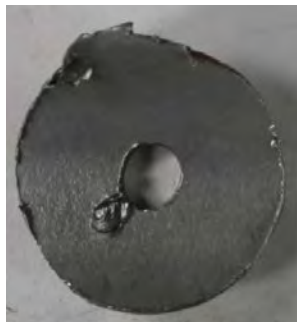
SOIL SIDE ALUMINUM COATING DATA:

- Surface area coated: 100%
- Minimum thickness: 0.73 mils
- Maximum thickness: 1.63 mils (41.5 μm)
- Maximum pit depth: 1.31 mils

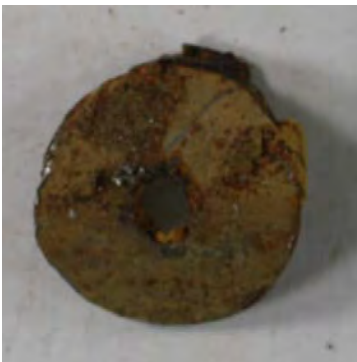
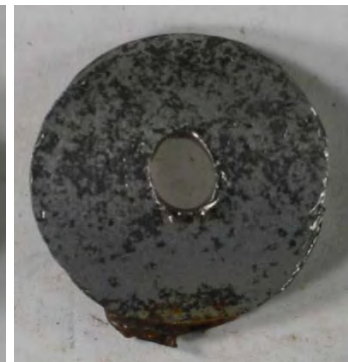
WATER SIDE ALUMINUM COATING DATA:

- Surface area coated: 80%
- Minimum thickness: 0.00 mils
- Maximum thickness: 1.25 mils (32 μm)
- Maximum pit depth: 2.73 mils

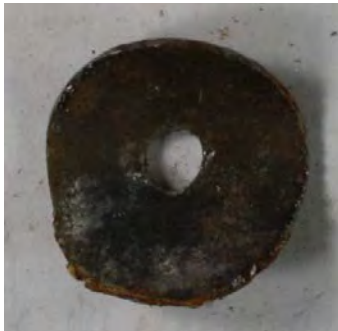
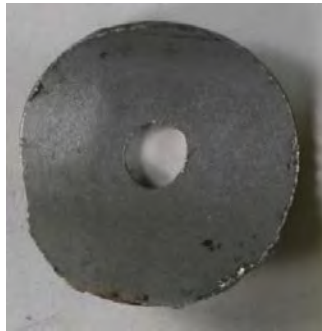
SOIL SIDE ALUMINUM COATING DATA:

- Surface area coated: 100%
- Minimum thickness: 0.72
- Maximum thickness: 1.61 (41 μm)
- Maximum pit depth: 0.87 mils

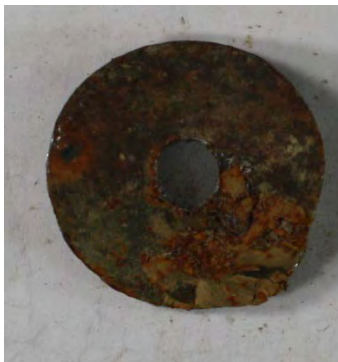
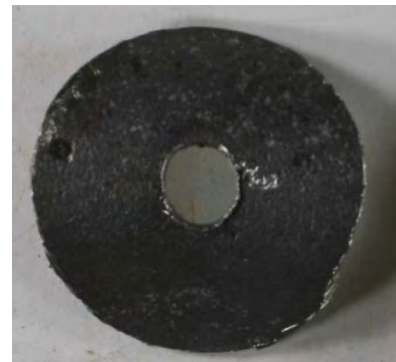
WATER SIDE ALUMINUM COATING DATA:

- Surface area coated: 5%
- Minimum thickness: 0.00
- Maximum thickness: 0.00
- Maximum pit depth: 23.00 mils

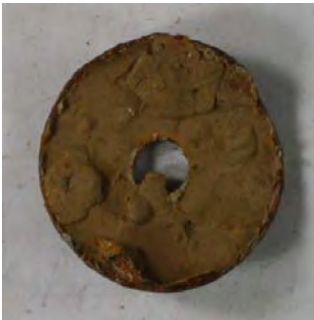
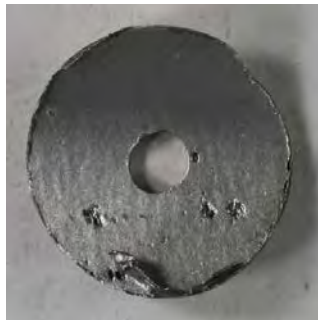
SOIL SIDE ALUMINUM COATING DATA:

- Surface area coated: 100%
- Minimum thickness: 0.84 mils
- Maximum thickness: 2.55 mils (65 µm)
- Maximum pit depth: 16.00 mils

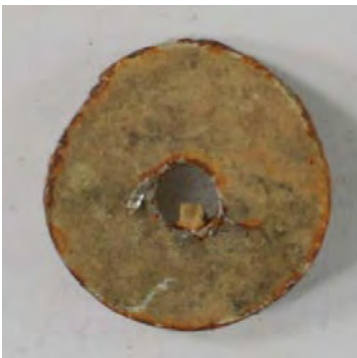
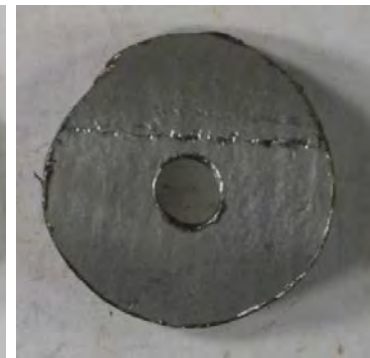
WATER SIDE ALUMINUM COATING DATA:

- Surface area coated: 100%
- Minimum thickness: 0.00 mils
- Maximum thickness: 2.03 mils (51 µm)
- Maximum pit depth: 1.38 mils

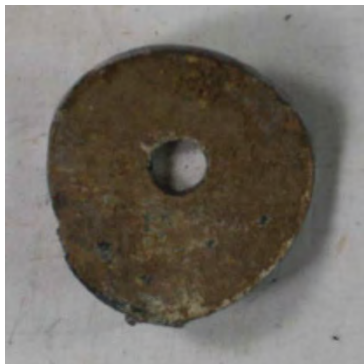
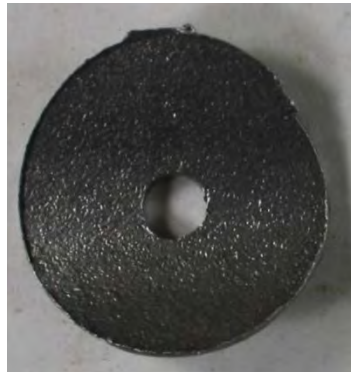
SOIL SIDE ALUMINUM COATING DATA:

- Surface area coated: 0%
- Minimum thickness: 0.00
- Maximum thickness: 0.00
- Maximum pit depth: 8.50 mils

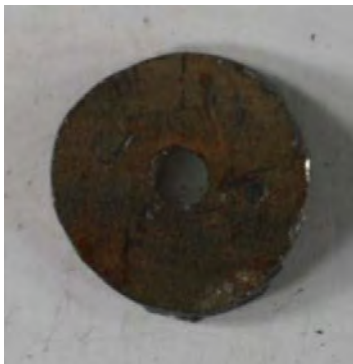
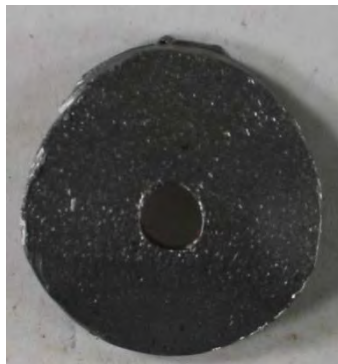
WATER SIDE ALUMINUM COATING DATA:

- Surface area coated: 0%
- Minimum thickness: 0.00
- Maximum thickness: 0.00
- Maximum pit depth: 5.21 mils

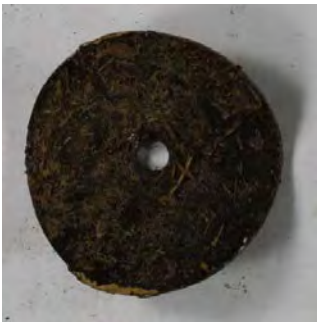
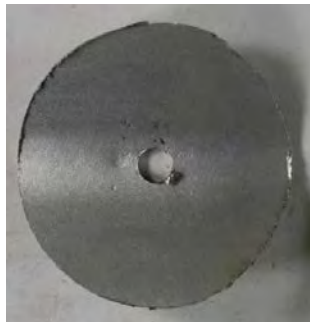
SOIL SIDE ALUMINUM COATING DATA:

- Surface area coated: 100%
- Minimum thickness: 1.24 mils
- Maximum thickness: 2.32 mils (60 μm)
- Maximum pit depth: 1.21 mils

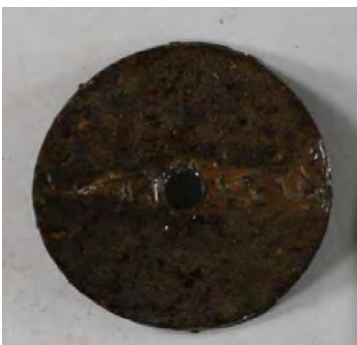
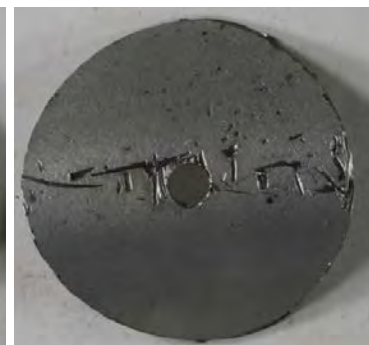
WATER SIDE ALUMINUM COATING DATA:

- Surface area coated: 100%
- Minimum thickness: 0.00 mils
- Maximum thickness: 3.68 mils (93 μm)
- Maximum pit depth: 4.31 mils

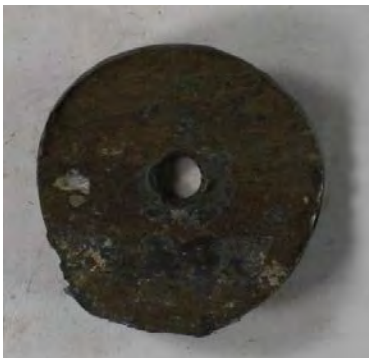
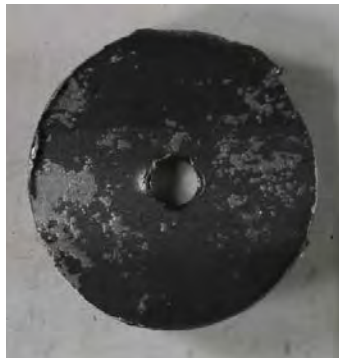
SOIL SIDE ALUMINUM COATING DATA:

- Surface area coated: 20%
- Minimum thickness: 0.00 mils
- Maximum thickness: 1.40 mils (35.5 μm)
- Maximum pit depth: 1.31 mils

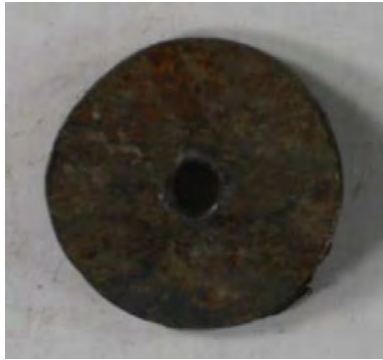
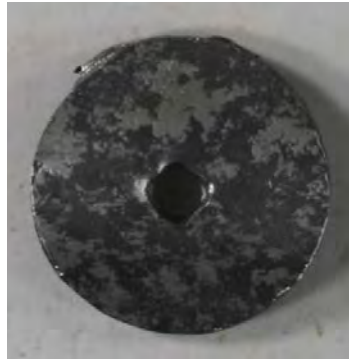
WATER SIDE ALUMINUM COATING DATA:

- Surface area coated: 40%
- Minimum thickness: 0.00 mils
- Maximum thickness: 0.89 mils (22.5 μm)
- Maximum pit depth: 2.57 mils

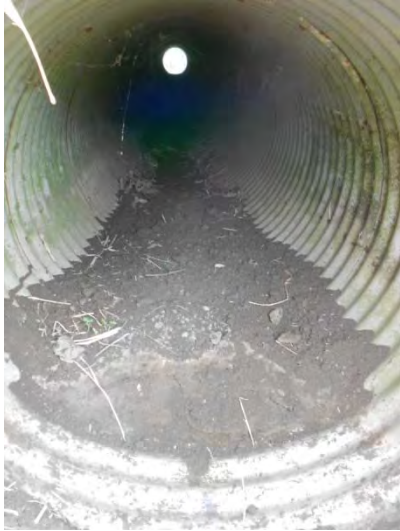
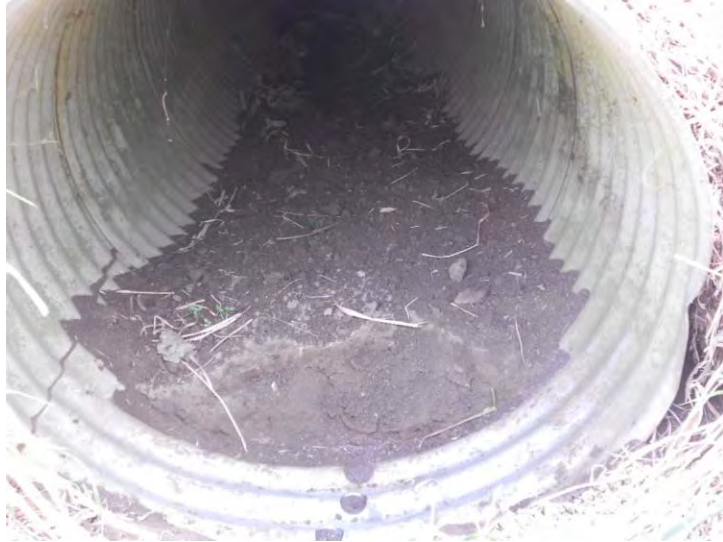
Marshall County #7, Iowa

DIAMETER	GAGE	YEAR INSTALLED	INSPECTION DATE
36" - RIVETED	12 (0.109 IN)	ESTIMATED AT 1953	JUNE, 2013
PROFILE	COATING	SOIL DATA	WATER DATA
2 2/3 X 1/2	ALUMINIZED TYPE 2	PH: 7	PH: 6.7
		RESISTIVITY: 1,330 Ω-CM	RESISTIVITY: 710 Ω-CM
			FHWA ABRASION LEVEL:2
			CHLORIDES: DRY
			CaCO ₃ : DRY

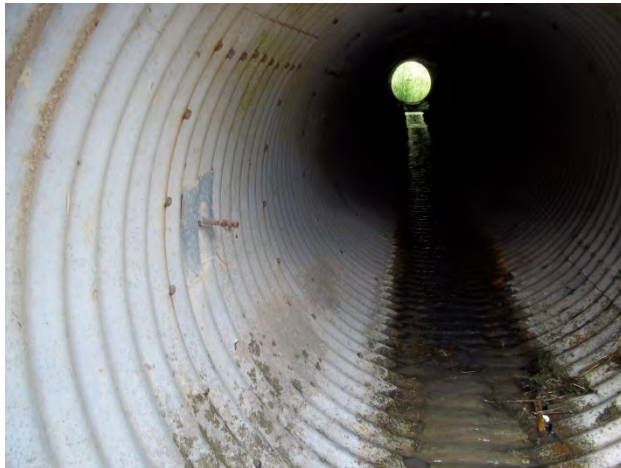
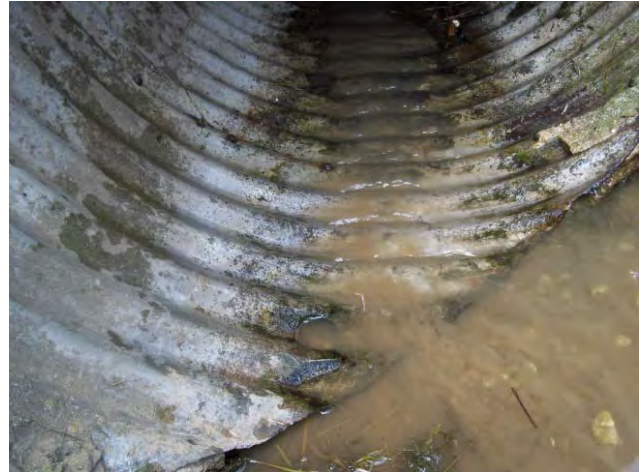
Morgan, Illinois

DIAMETER	GAGE	YEAR INSTALLED	INSPECTION DATE
36" - RIVETED	12 (0.109 IN)	ESTIMATED AT 1953	MAY, 2013
PROFILE	COATING	SOIL DATA	WATER DATA
2 2/3 X 1/2	ALUMINIZED TYPE 2	PH: 7	PH: 6.0
		RESISTIVITY: 2,860 Ω-CM	RESISTIVITY: 2,175 Ω-CM
			FHWA ABRASION LEVEL: 2
			CHLORIDES: N/A
			CaCO ₃ : 200 PPM

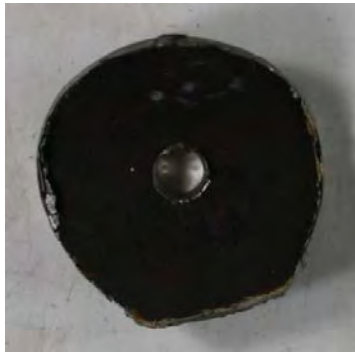
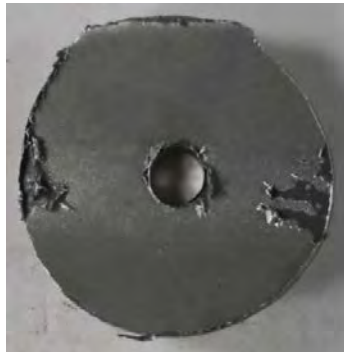
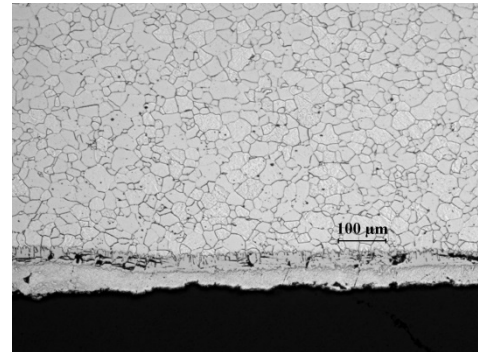
- Surface area coated: 100%
- Minimum thickness: 0.00 mils
- Maximum thickness: 2.53 mils (64 μm)
- Maximum pit depth: 1.97 mils

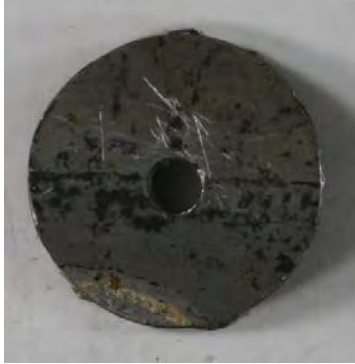
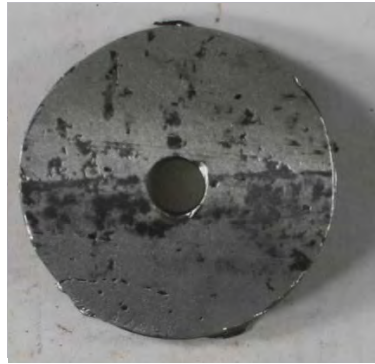
- Surface area coated: 85%
- Minimum thickness: 0.00 mils
- Maximum thickness: 1.71 mils (43 μm)
- Maximum pit depth: 8.00 mils

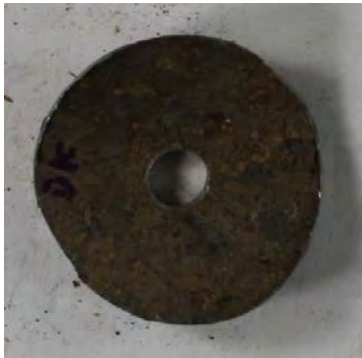
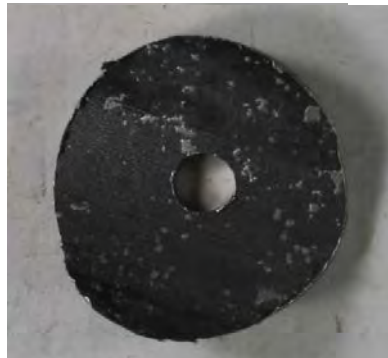
Dickinson County, KS

- Surface area coated: 5%
- Minimum thickness: 0.00 mils
- Maximum thickness: 0.00 mils
- Maximum pit depth: 0.73 mils

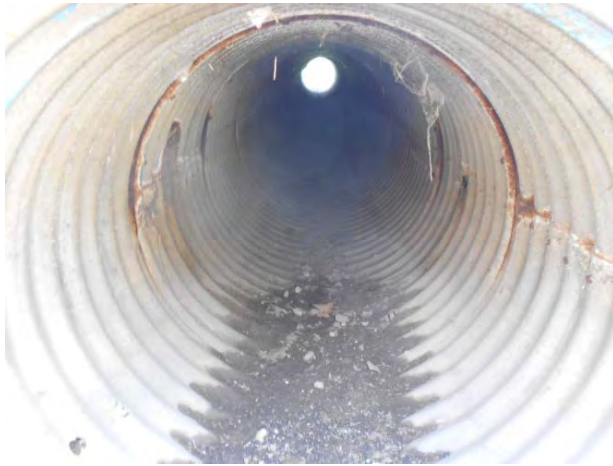
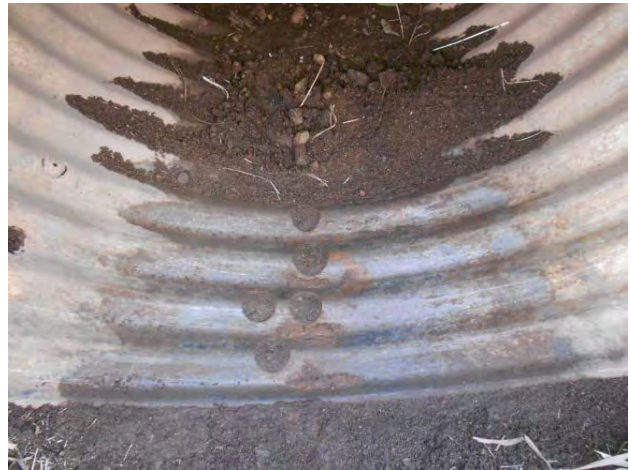
Pratt County, Kansas

DIAMETER	GAGE	YEAR INSTALLED	INSPECTION DATE
36" - RIVETED	14 (0.079 IN)	ESTIMATED AT 1953	MAY, 2013
PROFILE	COATING	SOIL DATA	WATER DATA
2 2/3 X 1/2	ALUMINIZED TYPE 2	PH: 7	PH: N/A
		RESISTIVITY: 3,290 Ω -CM	RESISTIVITY: N/A
			FHWA ABRASION LEVEL: 2
			CHLORIDES: DRY
			CaCO ₃ : DRY

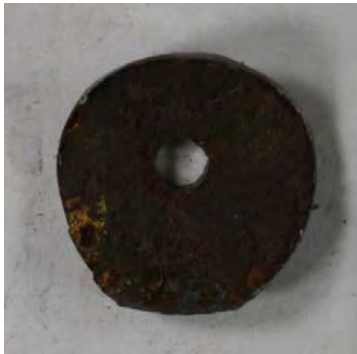
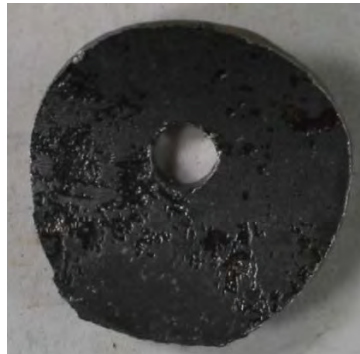
- Surface area coated: 5%
- Minimum thickness: 0.00 mils
- Maximum thickness: 0.00 mils
- Maximum pit depth: 14.00 mils

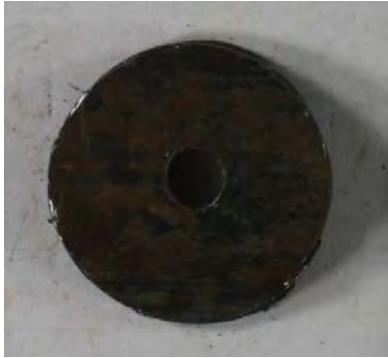
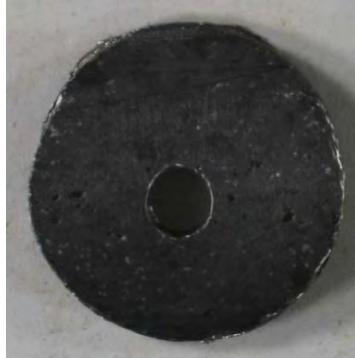
- Surface area coated: 5%
- Minimum thickness: 0.00 mils
- Maximum thickness: 0.00 mils
- Maximum pit depth: 12.00 mils

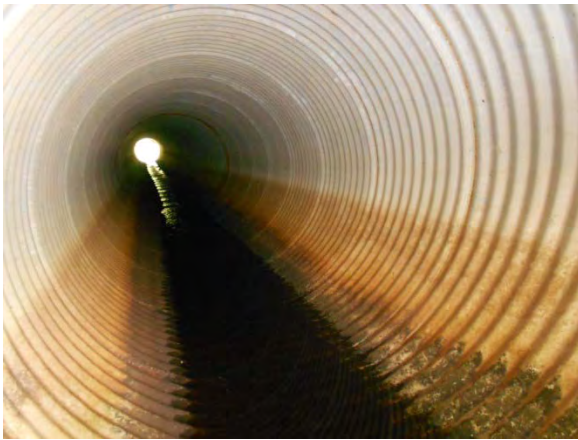
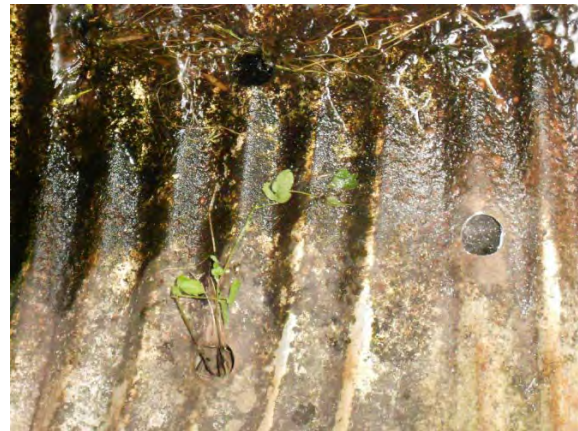
DIAMETER	GAGE	YEAR INSTALLED	INSPECTION DATE
48"	12 (0.109 IN)	ESTIMATED 1984	JUNE, 2012
PROFILE	COATING	SOIL DATA	WATER DATA
2 2/3 X 1/2	ALUMINIZED TYPE 2	PH: N/A	PH: 6
		RESISTIVITY: N/A	RESISTIVITY: N/A
			FHWA ABRASION LEVEL: 2
			CHLORIDES: N/A
			CaCO ₃ : 100

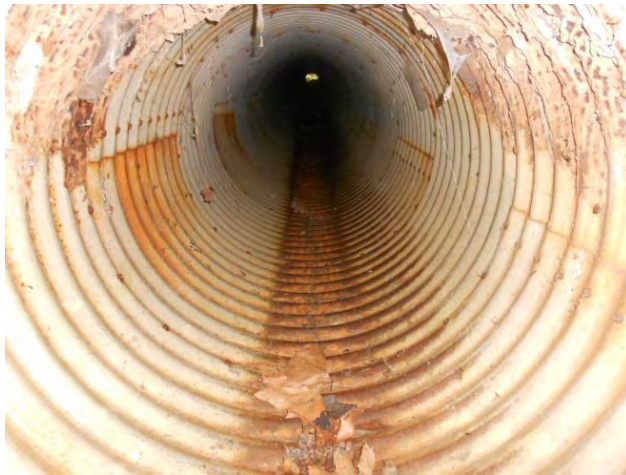
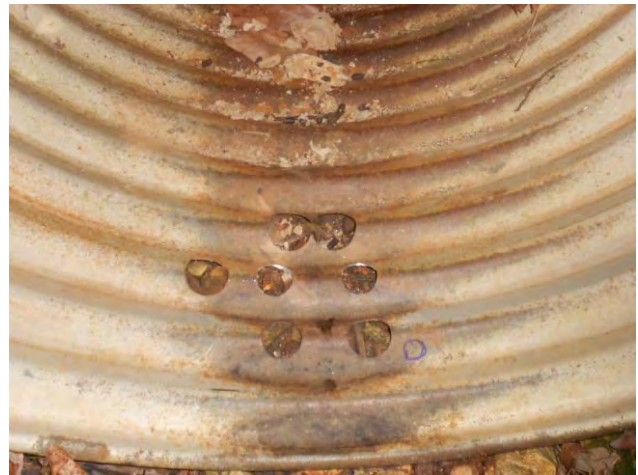
DIAMETER	GAGE	YEAR INSTALLED	INSPECTION DATE
30" - RIVETED	14 (0.079 IN)	ESTIMATED AT 1953	JUNE, 2013
PROFILE	COATING	SOIL DATA	WATER DATA
2 2/3 X 1/2	ALUMINIZED TYPE 2	PH: 6.7	PH: N/A
		RESISTIVITY: 1,420 Ω-CM	RESISTIVITY: N/A
			FHWA ABRASION LEVEL: 1
			CHLORIDES: DRY
			CaCO ₃ : DRY

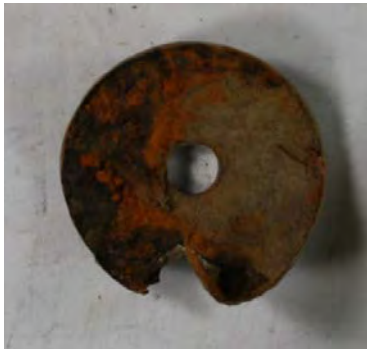
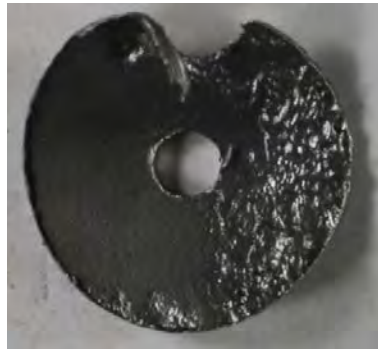
Bernalillo, New Mexico

- Surface area coated: 0%
- Minimum thickness: 0.00
- Maximum thickness: 0.00
- Maximum pit depth: 57.00 mils

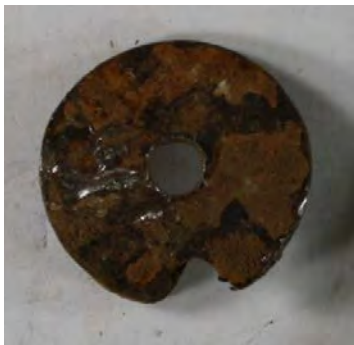
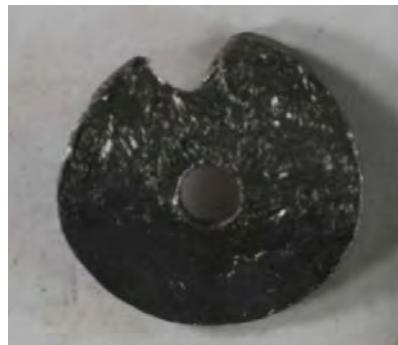
- Surface area coated: 0%
- Minimum thickness: 0.00
- Maximum thickness: 0.00
- Maximum pit depth: 26.00 mils

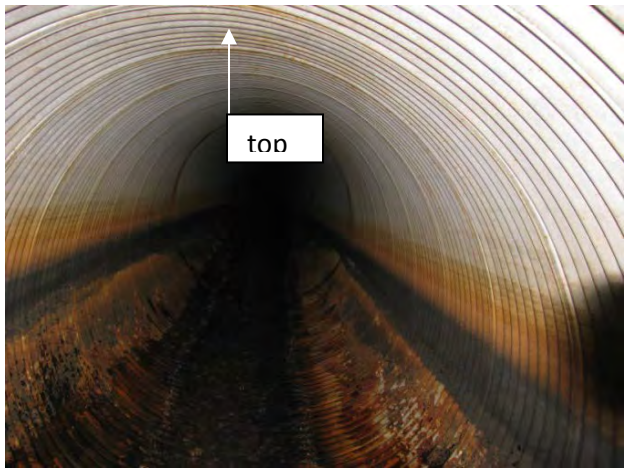
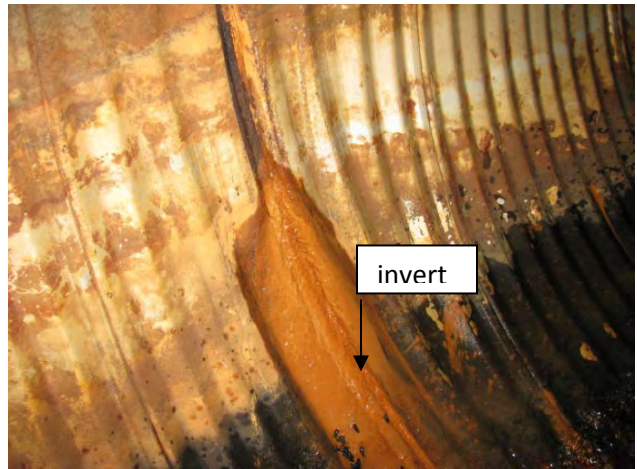
Cottage Grove (Anlauf), Oregon

DIAMETER	GAGE	YEAR INSTALLED	INSPECTION DATE
66"	12 (0.109 IN)	ESTIMATED AT 1993	MAY, 2013
PROFILE	COATING	SOIL DATA	WATER DATA
2 2/3 X 1/2	ALUMINIZED TYPE 2	PH: N/A	PH: 5.0
		RESISTIVITY: 2,860 Ω -CM	RESISTIVITY: 10,870 Ω -CM
			FHWA ABRASION LEVEL:
			CHLORIDES: <1
			CaCO ₃ : 40 - 80 PPM

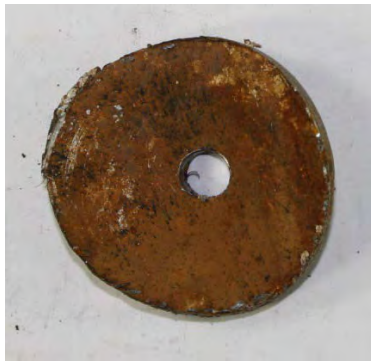
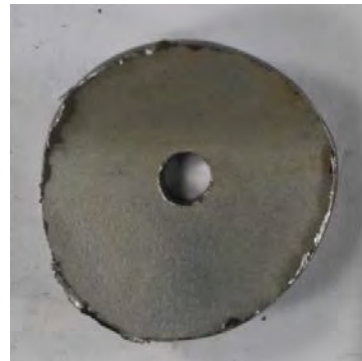
- Surface area coated: 100%
- Minimum thickness: 0.00 mils
- Maximum thickness: 1.87 mils (47.5 μ m)
- Maximum pit depth: 1.60 mils

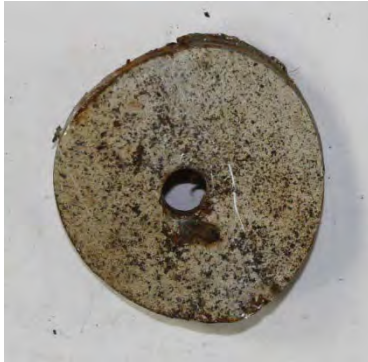
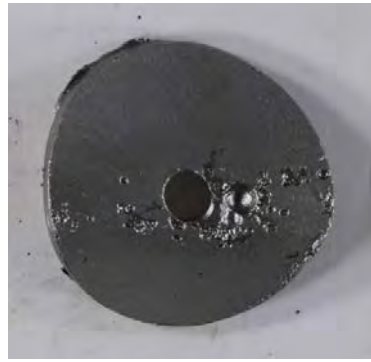
- Surface area coated: 90%
 - Minimum thickness: 0.00 mils
 - Maximum thickness: 2.19 mils (55.5 μ m)
 - Maximum pit depth: 11.00 mils
- *Note: largest visible pit is a result of the removal process

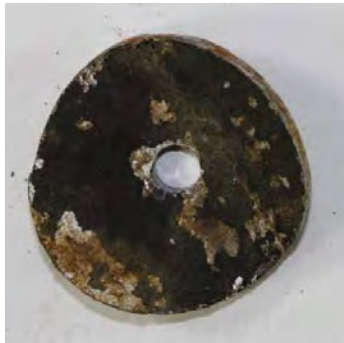
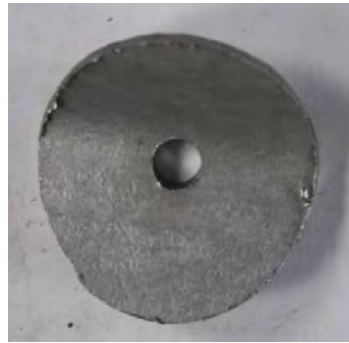
- Surface area coated: 100%
- Minimum thickness: 1.63 mils
- Maximum thickness: 2.36 mils (60 μm)
- Maximum pit depth: 0.00 mils

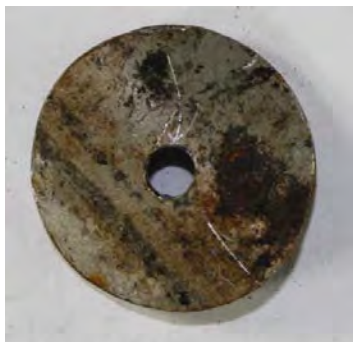
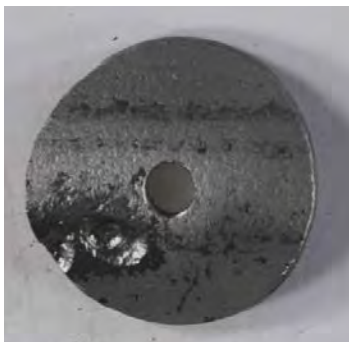
- Surface area coated: 60%
- Minimum thickness: 0.00 mils
- Maximum thickness: 2.78 mils (70 μm)
- Maximum pit depth: 81.00 mils

*Note: largest visible pit is a result of the removal process

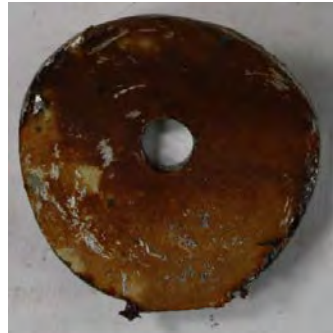
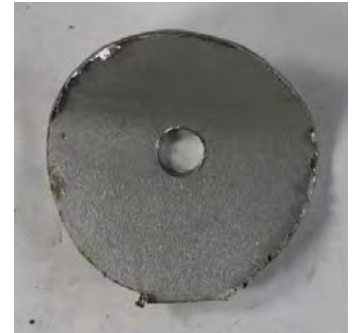
- Surface area coated: 100%
- Minimum thickness: 0.00 mils
- Maximum thickness: 1.45 mils (37 μm)
- Maximum pit depth: 0.94 mils

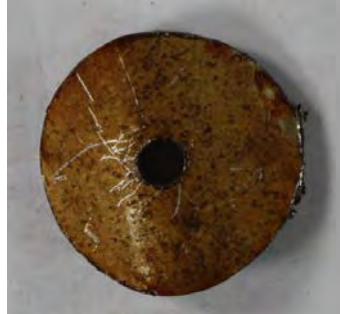
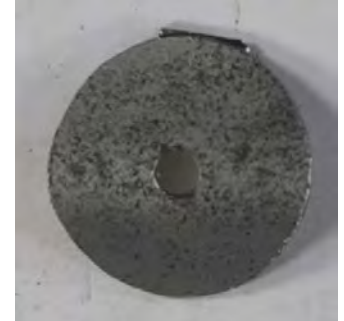
- Surface area coated: 80%
- Minimum thickness: 0.00 mils
- Maximum thickness: 2.31 mils (58.5 μm)
- Maximum pit depth: 1.54 mils

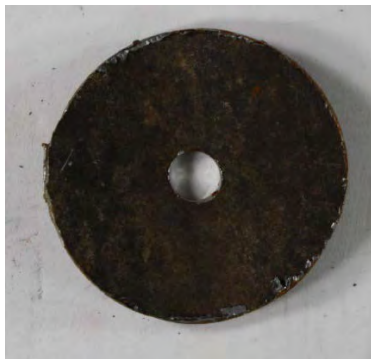
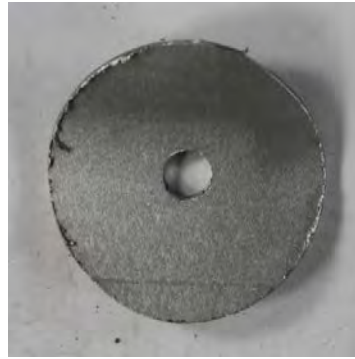
- Surface area coated: 100%
- Minimum thickness: 0.55 mils
- Maximum thickness: 2.28 mils (58 μm)
- Maximum pit depth: 1.35 mils

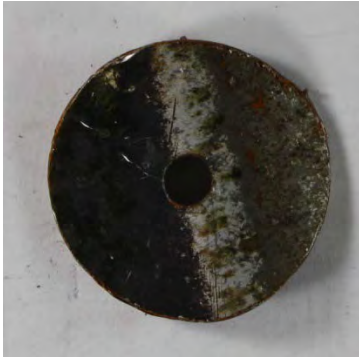
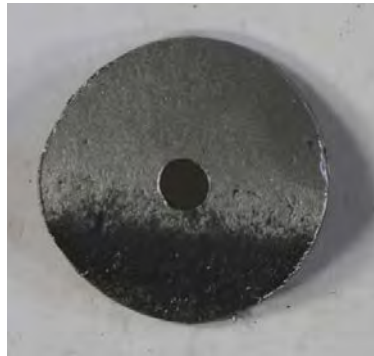
- Surface area coated: 65%
- Minimum thickness: 0.00 mils
- Maximum thickness: 1.72 mils (43.5 μ m)
- Maximum pit depth: 4.97 mils

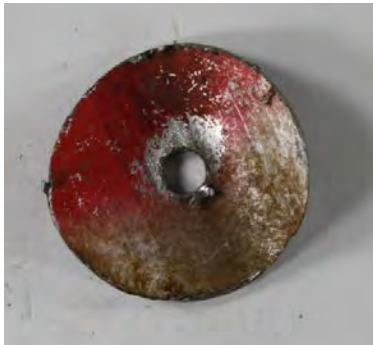
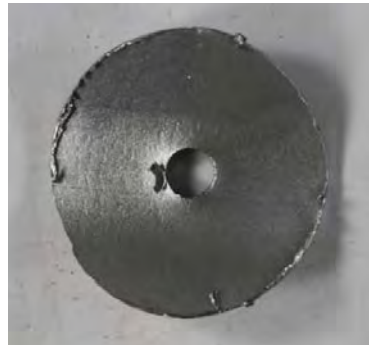
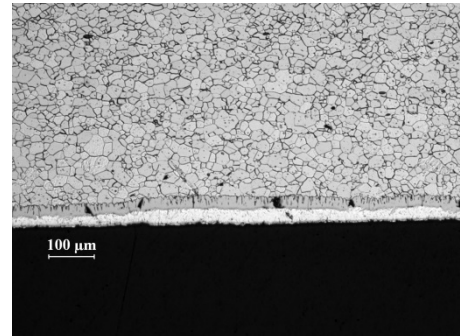
- Surface area coated: 100%
- Minimum thickness: 1.00 mils
- Maximum thickness: 3.01 mils (76.5 μ m)
- Maximum pit depth: 0.87 mils

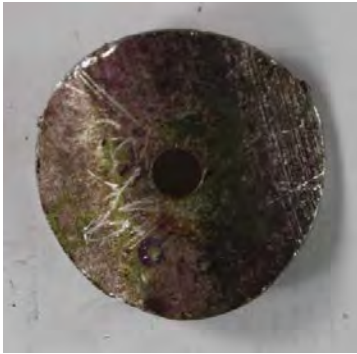
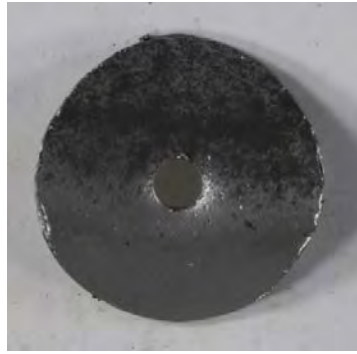
- Surface area coated: 55%
- Minimum thickness: 0.00 mils
- Maximum thickness: 1.05 mils (26.5 μm)
- Maximum pit depth: 2.28 mils

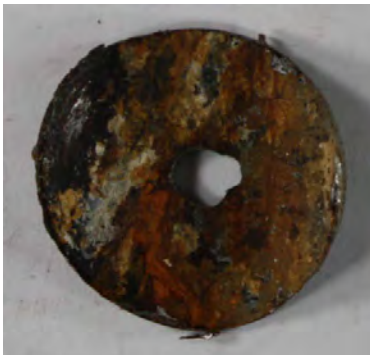
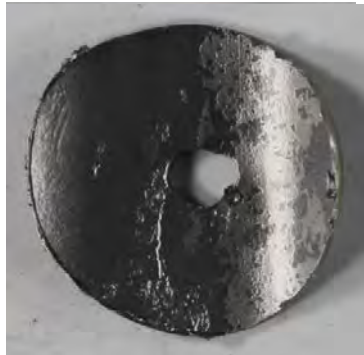
- Surface area coated: 30%
- Minimum thickness: 0.00
- Maximum thickness: 0.88 (22 μm)
- Maximum pit depth: 35.50 mils

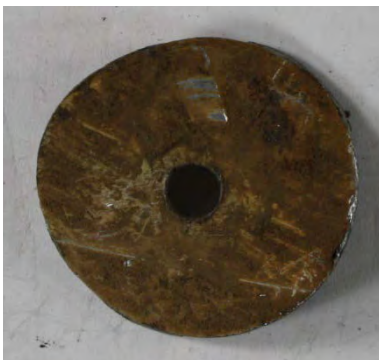
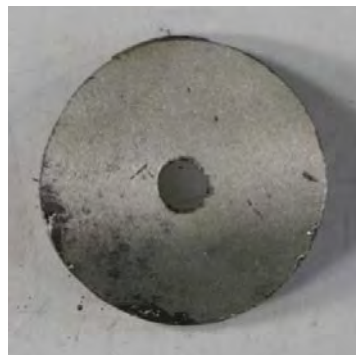
- Surface area coated: 0%
- Minimum thickness: 0.00
- Maximum thickness: 0.00
- Maximum pit depth: 51.50 mils

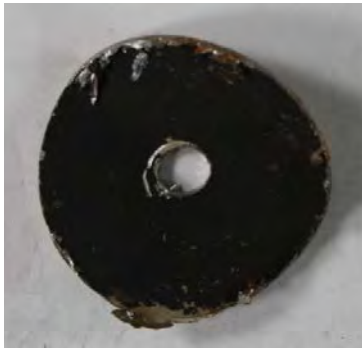
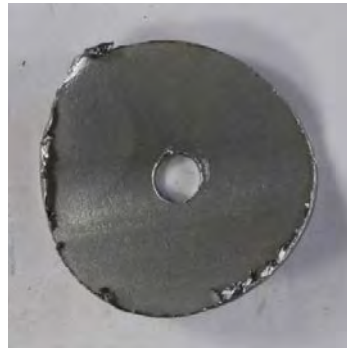
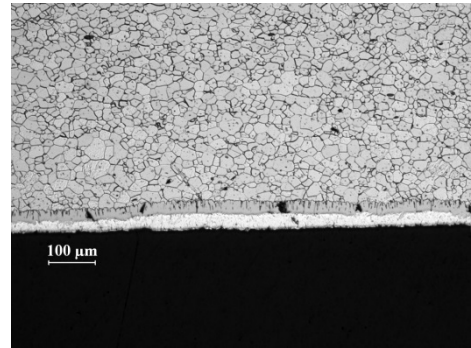
- Surface area coated: 100%
- Minimum thickness: 0.87 mils
- Maximum thickness: 1.42 mils (36 μm)
- Maximum pit depth: 3.38 mils

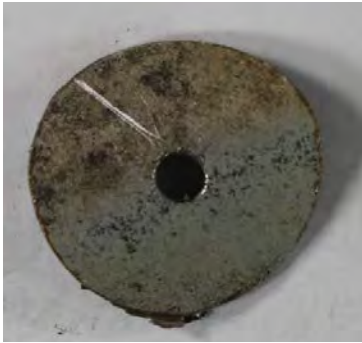
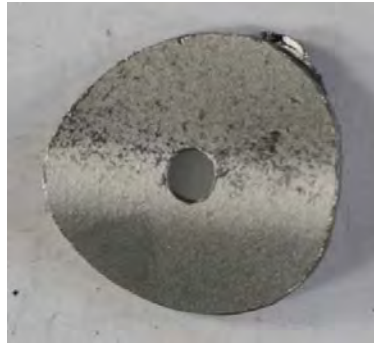
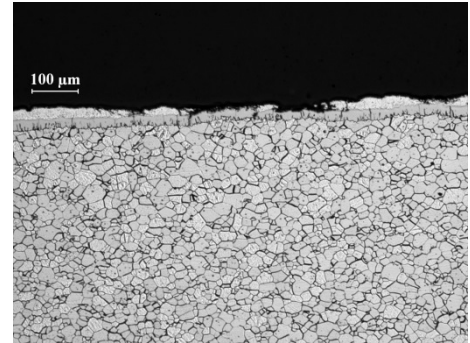
- Surface area coated: 95%
- Minimum thickness: 0.00 mils
- Maximum thickness: 1.66 mils (42 μm)
- Maximum pit depth: 5.00 mils

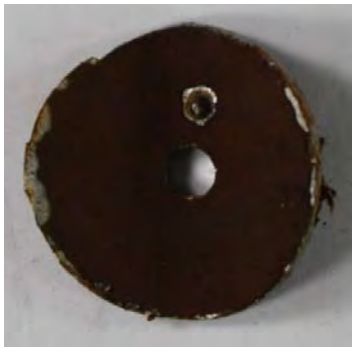
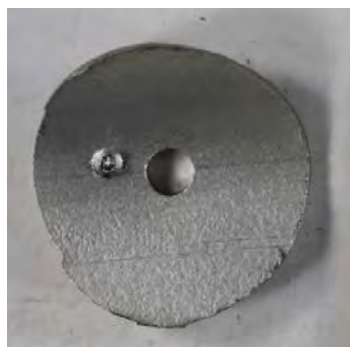
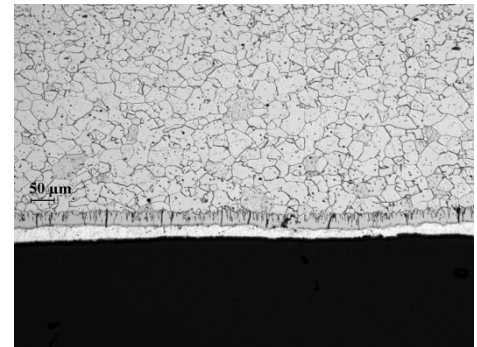
- Surface area coated: 100%
 - Minimum thickness: 0.93 mils
 - Maximum thickness: 2.09 mils (53 μ m)
 - Maximum pit depth: 1.16 mils
- *Note: largest visible pit is a result of the removal process

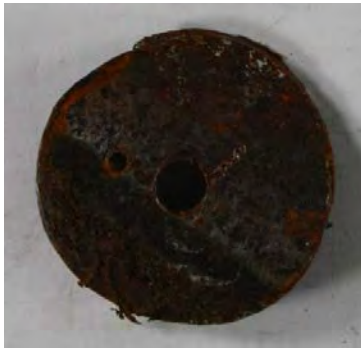
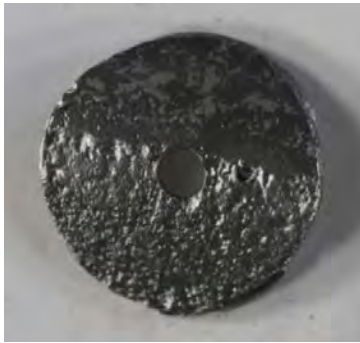
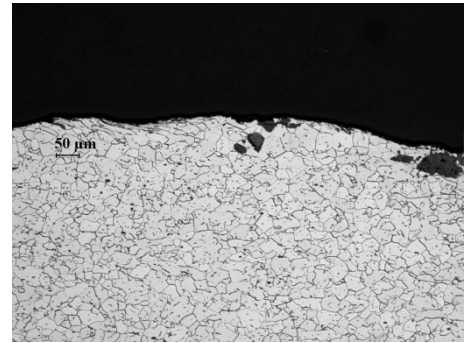
- Surface area coated: 10%
- Minimum thickness: 0.00 mils
- Maximum thickness: 0.00 mils (42 μm)
- Maximum pit depth: 20.00 mils

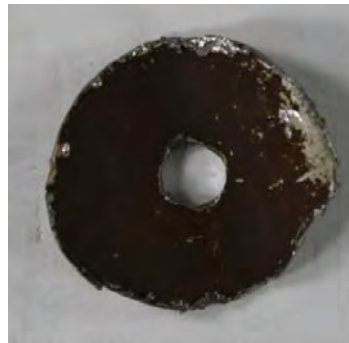
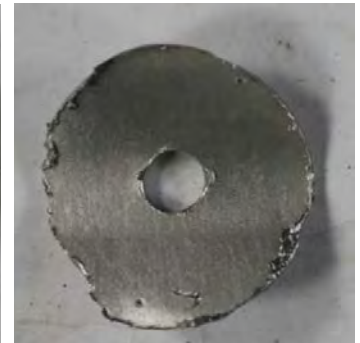
- Surface area coated: 100%
- Minimum thickness: 0.00 mils
- Maximum thickness: 1.07 mils (27 μm)
- Maximum pit depth: 1.20 mils

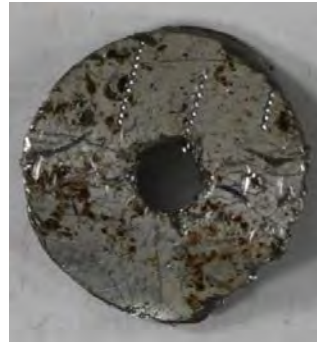
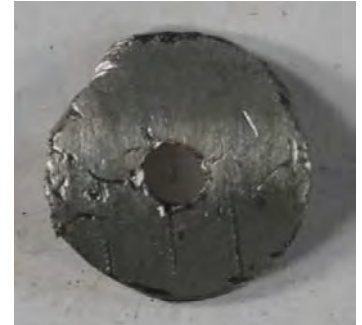
- Surface area coated: 100%
 - Minimum thickness: 0.00 mils
 - Maximum thickness: 1.46 mils (37 μm)
 - Maximum pit depth: 1.13 mils
- *Note: largest visible pit is a result of the removal process

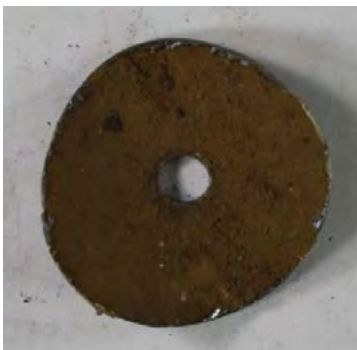
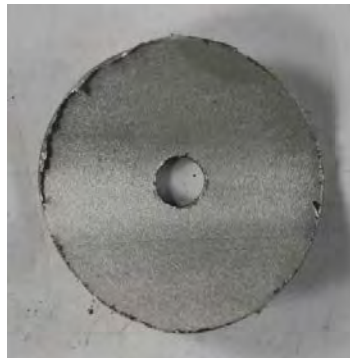
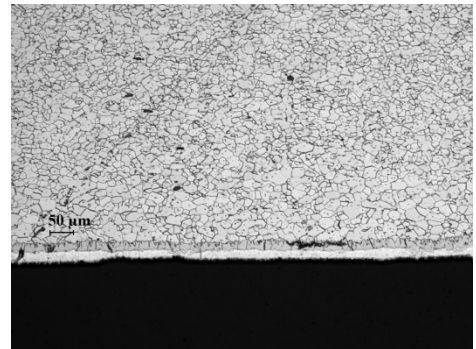
- Surface area coated: 100%
- Minimum thickness: 0.55 mils
- Maximum thickness: 3.04 mils (77 μ m)
- Maximum pit depth: 1.60 mils

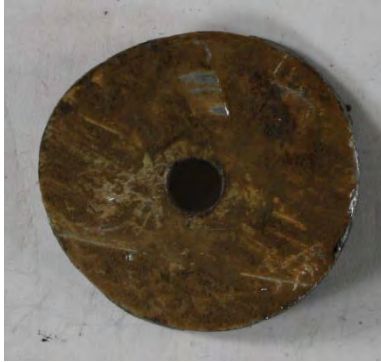
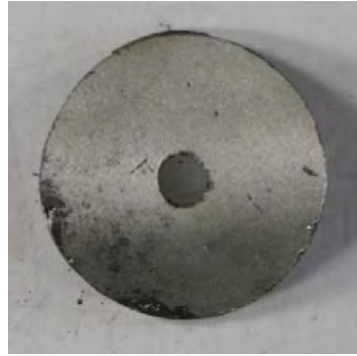
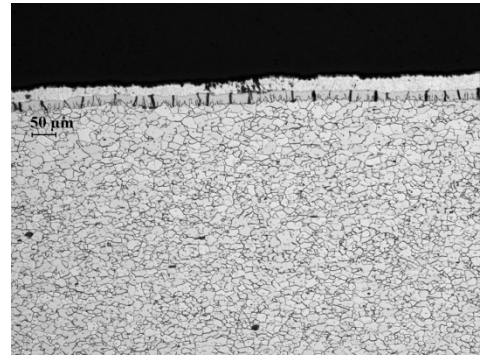
Santiam Highway New Site 1, Oregon

- Surface area coated: 95%
 - Minimum thickness: 0.37 mils
 - Maximum thickness: 1.584 mils (40 μm)
 - Maximum pit depth: 0.67 mils
- *Note: largest visible pit is a result of the removal process

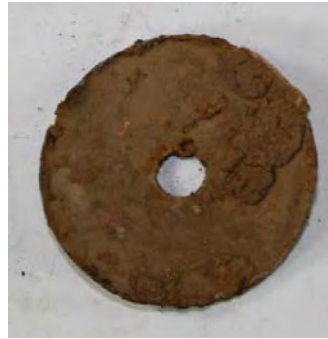
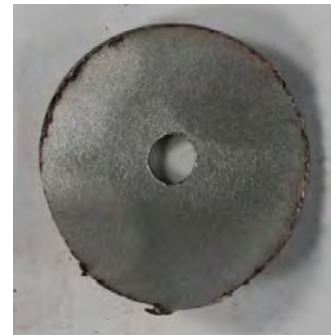
- Surface area coated: 100%
- Minimum thickness: 0.94 mils
- Maximum thickness: 2.18 mils (55 µm)
- Maximum pit depth: 1.02 mils

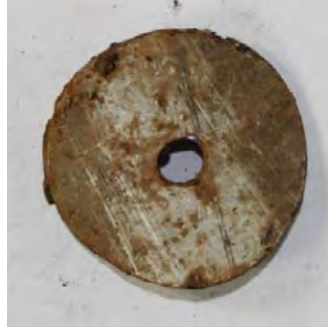
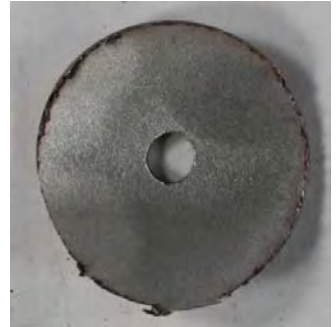
- Surface area coated: 95%
- Minimum thickness: 0.00 mils
- Maximum thickness: 2.03 mils (51.5 µm)
- Maximum pit depth: 9.00 mils
