National
Corrugated Steel Pipe
Association

Condition Survey of Corrugated Steel Pipe Detention Systems

An Interim Report
March, 1999

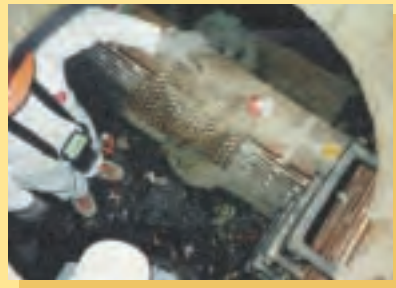
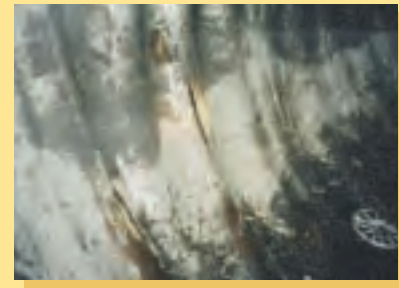
Top90/95
 Sides90/95
 Invert75
Avg. Rating.....86.7

Comments:
 36" saw-cuts in every
 corrugation to promote
 infiltration;
 stone backfill.

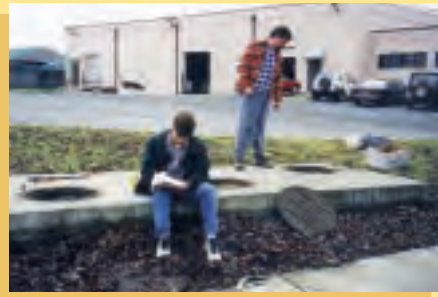
Top100
 Sides100
 Invert90
Avg. Rating.....96.7

Oil grit separator at
entrance.

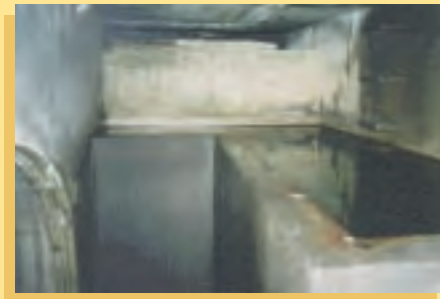
Top	95
Sides	95
Invert	85
Avg. Rating.....	91.2

Oil grit separator at
entrance;
minor soil trough joints;
no sign of gaskets with
joints.

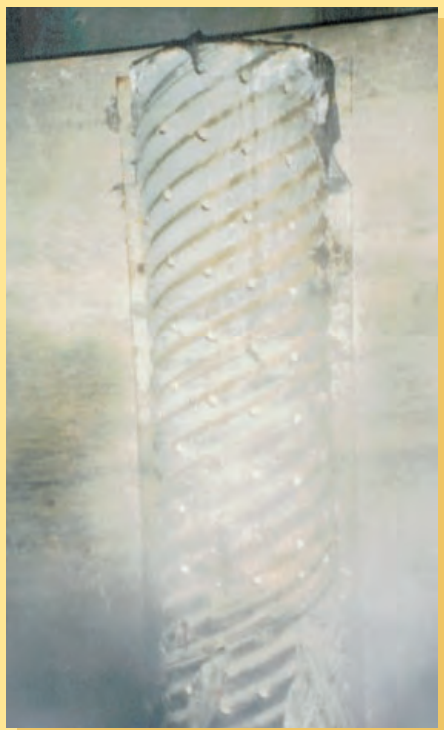
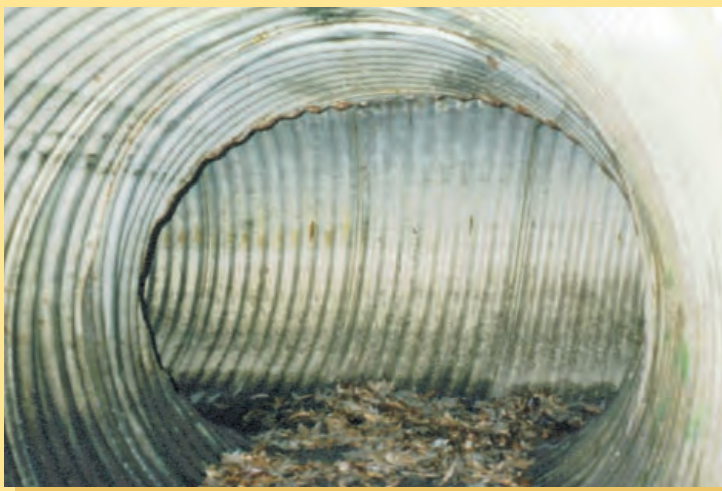
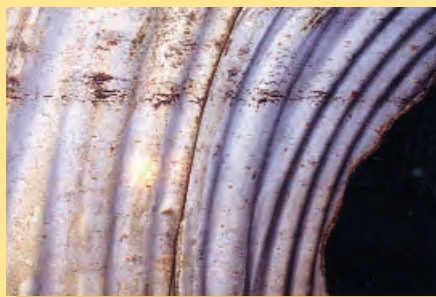
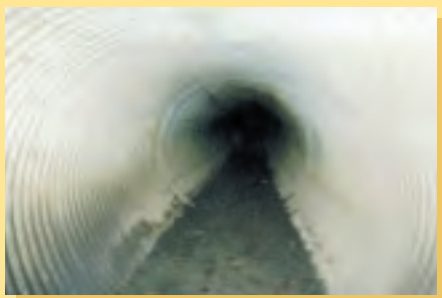
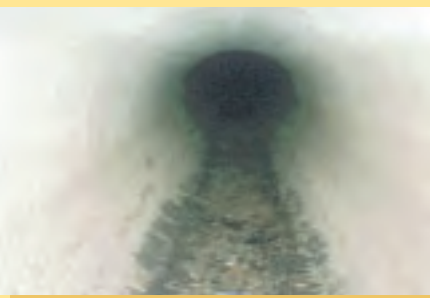
Top90
 Sides90/100
 Invert80/85
Avg. Rating.....88.3

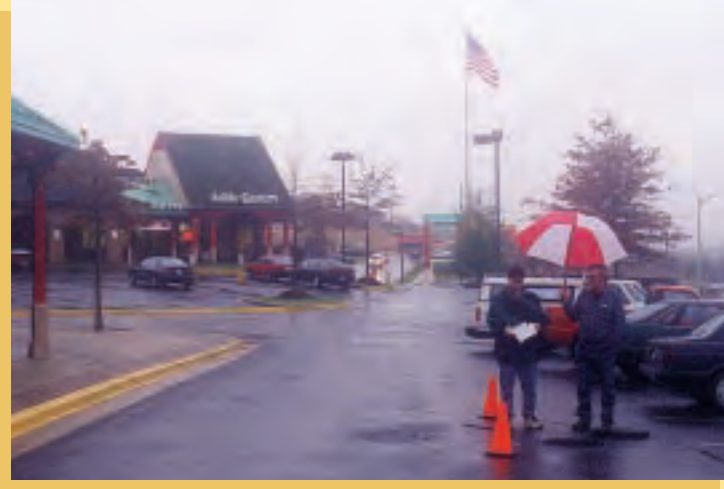
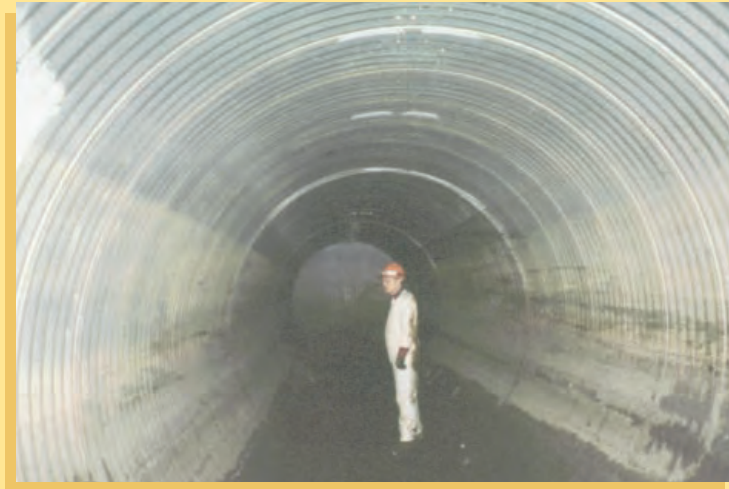
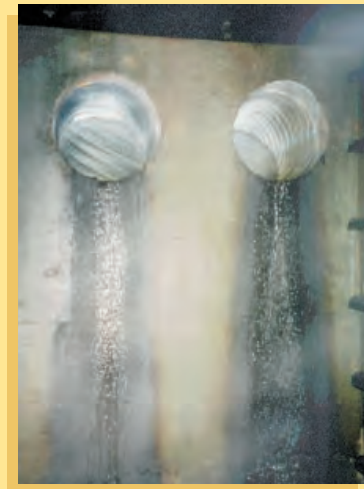
<p>Condition Rating</p>	<p>Age: 10 years Coating Type: Aluminum Coated Type 2 Diameter: 108" Corrugation: 1x5" Helical Land Use: Commercial Location: Montgomery County, Maryland</p>	<p>Comments: <u>Oil grit separator at entrance.</u> <hr/> <hr/> <hr/> <hr/></p>
<p>Top95 Sides95 Invert95 Avg. Rating95</p>

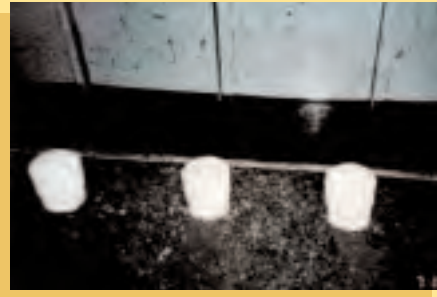
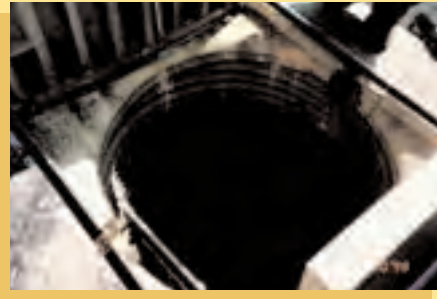
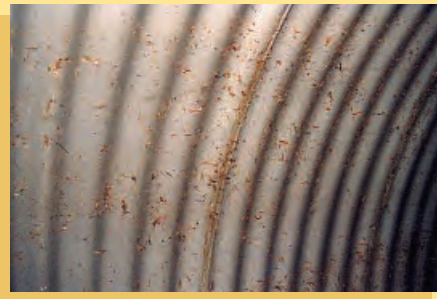
Top	100
Sides	100
Invert	N/A
Avg. Rating	100

Well drained;
 no signs of sediment
 clogging.

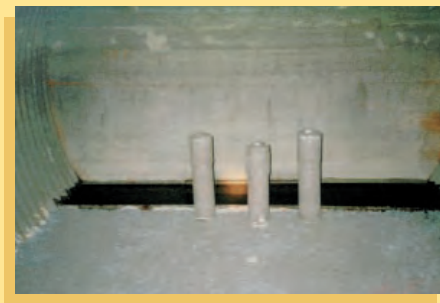
Top95/100
 Sides95/100
 InvertN/A
Avg. Rating.....97.5

Little to no debris;
no signs of clogging;
return valve open.

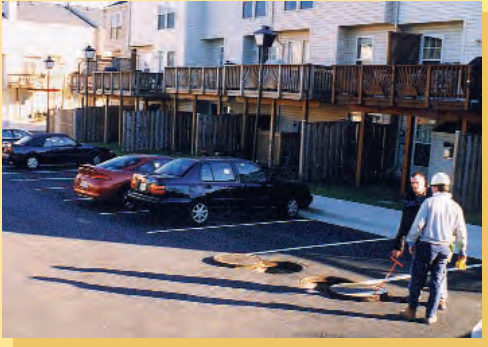
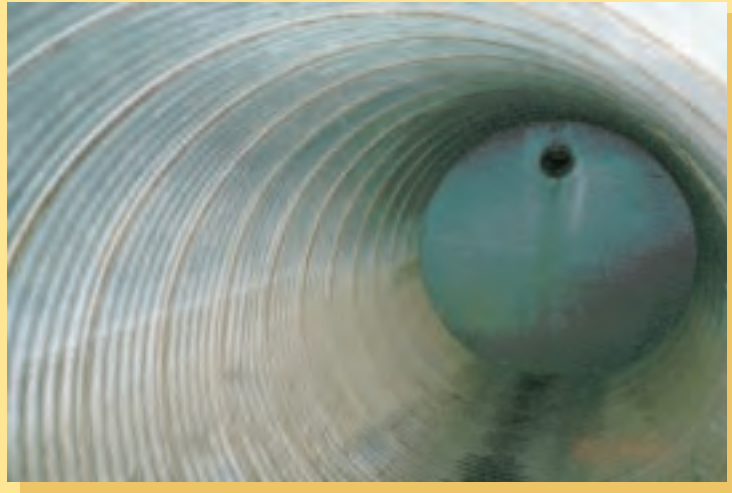
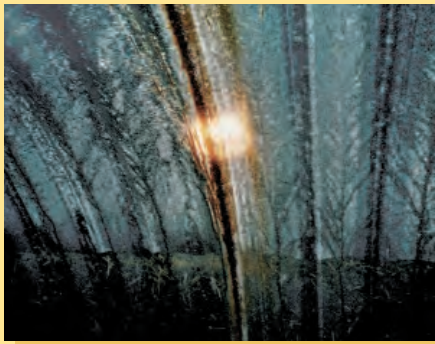
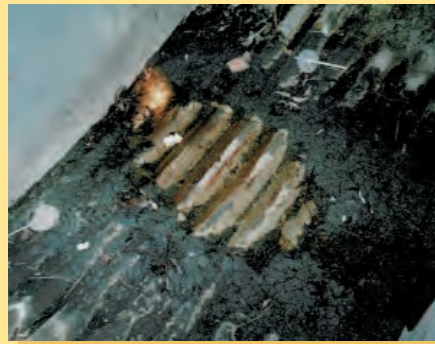
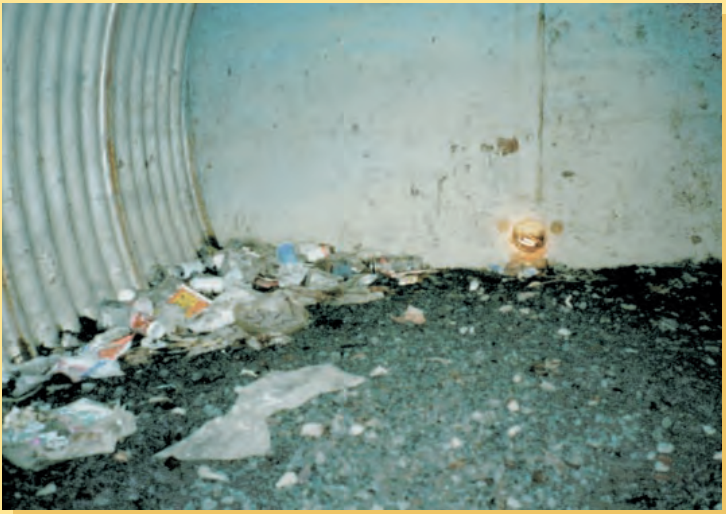
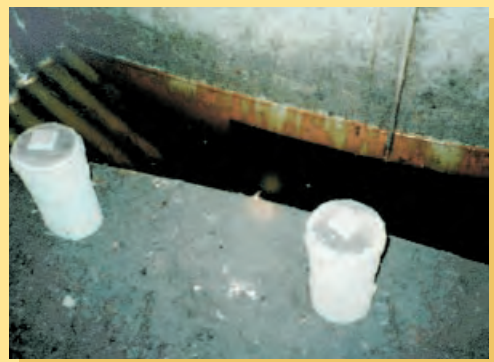
<p>Condition Rating</p>	<p>Age: 5 years Coating Type: Galvanized Diameter: 144" Corrugation: 1x5" Helical Land Use: Residential Location: Alexandria, Virginia</p>	<p>Comments: <u>Detention system with</u> <u>sand filter.</u> <hr/> <hr/> <hr/></p>
<p>Top95 Sides95 Invert95 Avg. Rating95</p>
