Scandia Valley TWP | Scandia Valley, MN

38'x63" Outside Dia. Snap Tite

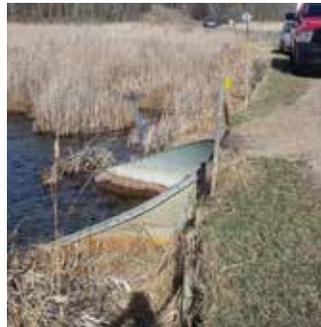
BEFORE

Existing 72" CMP exceeded the life expectancy and a 63" outside diameter was used to slip line, bulk head, and grout annular space.

Installed in current water depth of estimated 3'. Road needed to remain open during construction. Only one access in and out.
