Corrugated Steel Structural Plate Pipe Rehabilitation | Fort Yates, ND

Polymer Coated Corrugated Steel Pipe

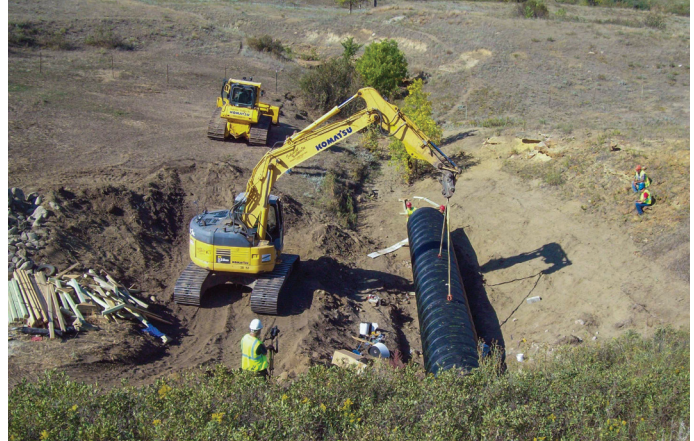
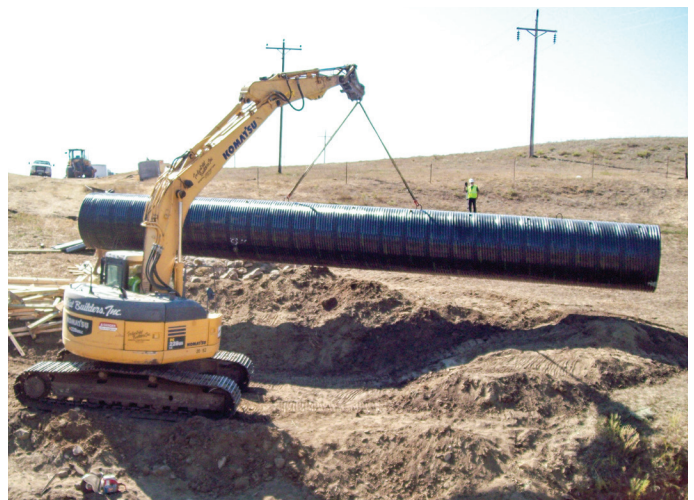
Relining of existing structural plate pipe with 60" dia. 10 gauge polymer coated corrugated steel pipe. Liner pipe was installed and back-grouted in place in the existing conduit to extend the service life an additional 75 years.

The polymer coated corrugated steel pipe was slipped into the existing structure on skids attached to the bottom of the pipe.

TrueNorth Steel provided extra long pipe lengths to minimize the number of pipe connections. Connections consisted of 24" wide gasketed bands to eliminate leakage of the grout in the annular space between the liner pipe and host pipe.
