North Dakota State Highway 127 Culvert Rehabilitation | Fairmount, ND

CSP Aluminized Steel Type II Spiral Rib Pipe

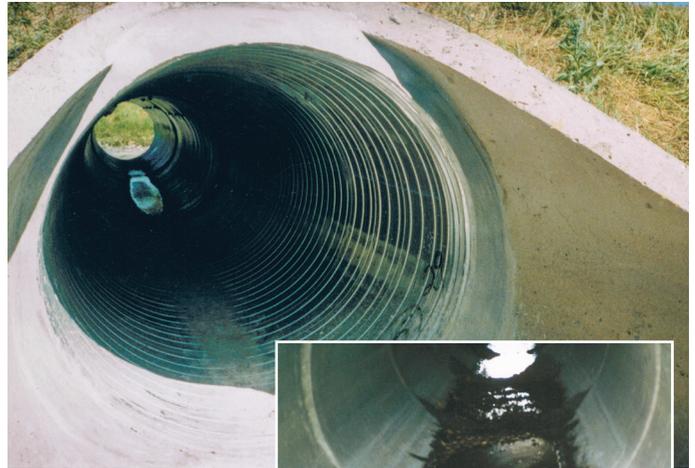
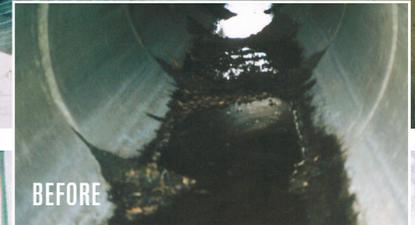
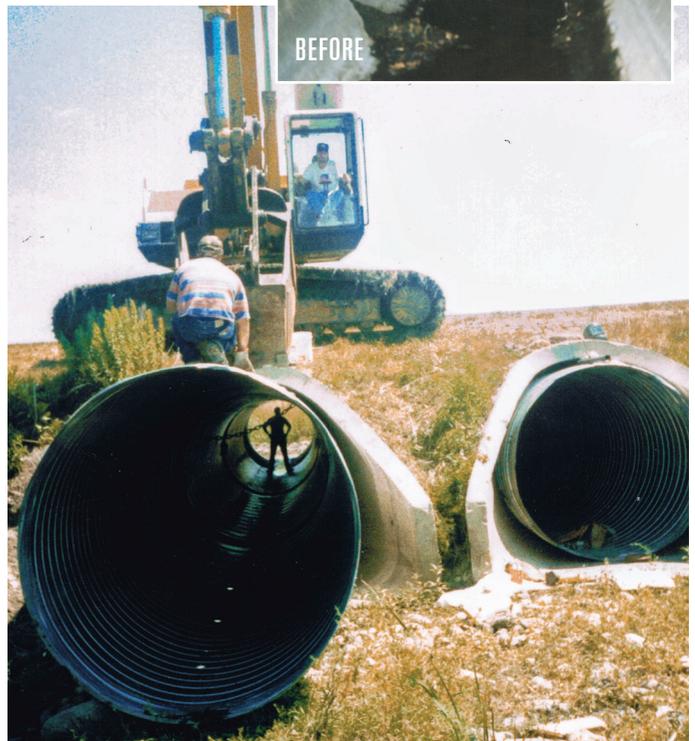
Existing concrete pipe joints were misaligned and leaking both soil and water. Spiral rib CSP was chosen because of its Manning's "n" = .012. This allows for maximizing hydraulic capacity.

The liner pipe was installed and the annulus was grouted through internal ports. The installation process minimized the time required to rehabilitate this existing pipe.
