BNSF Rehabilitation | DEVILS LAKE, ND

120" Dia 8 Ga. 5x1 Galvanized Pipe

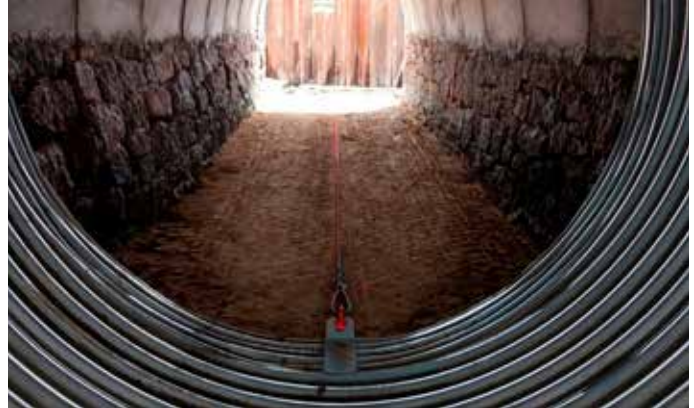
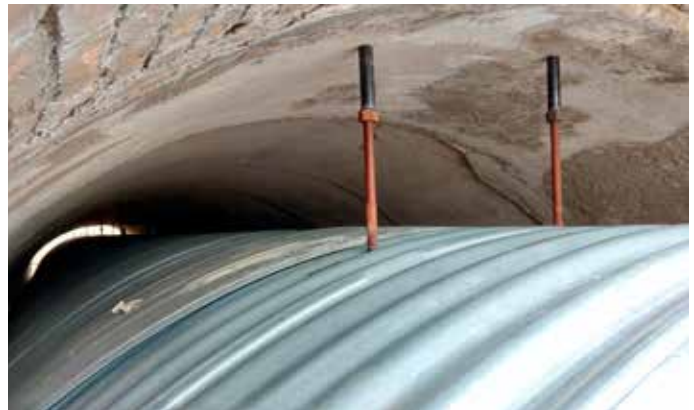
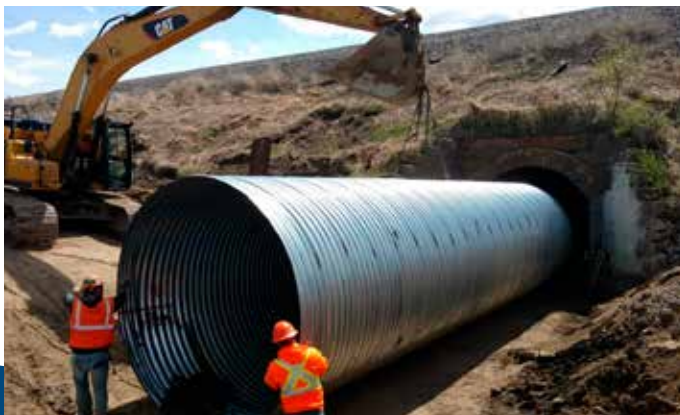
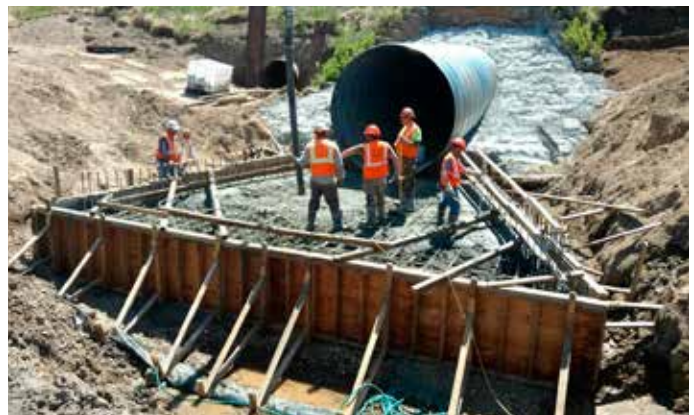
A 120" diameter galvanized pipe was used to reline an existing concrete structure. Contractor stated "... an impressive product was delivered and banded together with very little effort".

The original plan for a more structural backfill did not work and since they basically just needed to fill the void, a local ready mix supplied a non-shrink solution mixture that met those requirements.
