NCSPA's Rehabilitation Project of the Year | Douglas County, WY

Triple Barrel 108" Dia, Galvanized 10 Ga, 5x1 Corrugation with Head and Wing Walls

Douglas Wyoming Railroad Bridge Rehabilitation

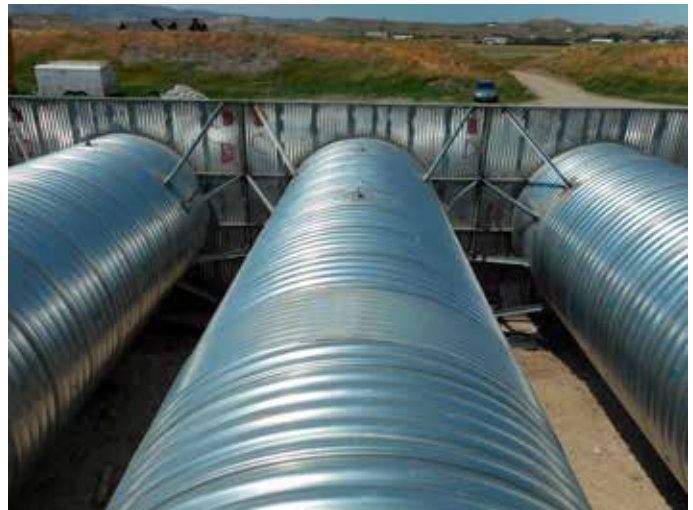
A triple barrel 108" diameter, galvanized coated, 10 gauge, 5" x 1" corrugated steel pipe was utilized to handle the hydraulics of the site. Head and wing walls were added to contain the backfill material and carry the concentrated rail load and improve the hydraulic capacity.

For the Douglas Wyoming Railroad Bridge, corrugated steel pipe was the solution to the rehabilitation of this old railroad timber structure.

The most important part of this rehab project was keeping the crossing open through the entire installation process.
