AGRICULTURE

POTATO FARM STORAGE VENTILATION PIPE

LOCATION	COMPLETION DATE	PRODUCT	SCOPE
Robinson, ND	August 2022	Vent Pipe	Over 1,275 Feet

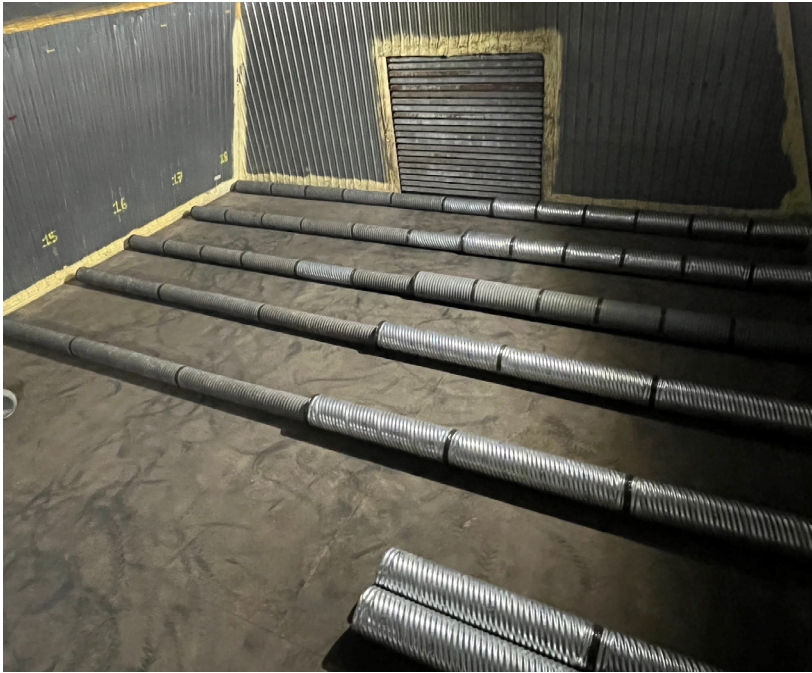
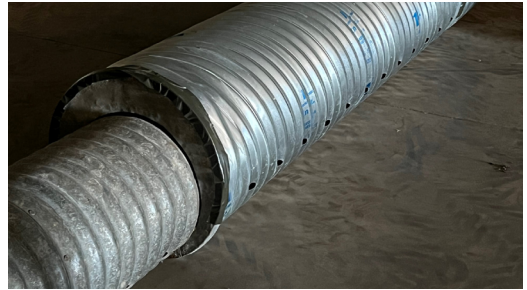
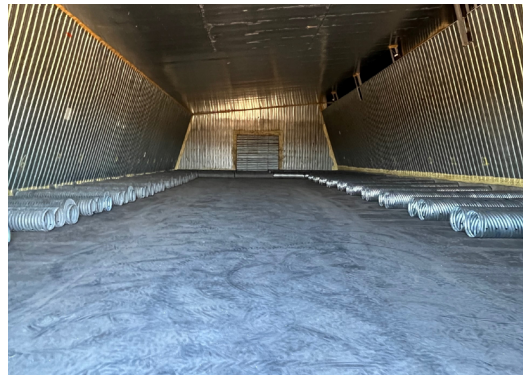
A central North Dakota farm had a unique problem: the vent pipe in their potato storage building was prone to crimping and flattening under the weight of a full crop load. Without proper ventilation, the produce would be prone to spoilage.

Sales and engineering representatives from TrueNorth Steel's Corrugated Steel Pipe (CSP) division visited the farm to help determine a calculated solution: replace the current, too pliable vent pipe with more heavy-duty 14 gauge pipe in 18 and 24-inch in diameter sections that will withstand the weight of the crop load and prevent future vent blockage. The representatives incorporated more cost-effective materials where applicable while working with multiple TrueNorth Steel manufacturing facilities to deliver a vent pipe product made to the project's custom specifications while staying on budget and on schedule.
